# INTERDISCIPLINARY STUDY FOR KNOWLEDGE AND DATING OF THE SAN FRANCESCO CONVENT IN STAMPACE, CAGLIARI – ITALY (XIII-XXI CENTURY)

**KEYWORDS:** Chronological methods, interdisciplinary approach, Laser Scanner, survey, geomaterial characterization.

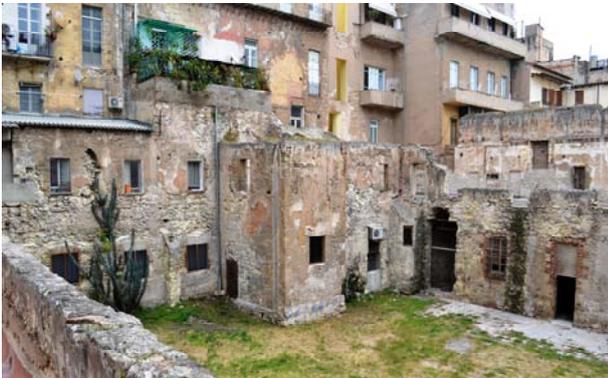
Figure 1: The St. Francis complex in its present state, as seen from the south-west direction

The St. Francis architectural complex was formed originally by a church and a series of buildings used as a convent, surrounding a large cloister, whose main axes are oriented in the north-east to south-west direction (Figure 1).

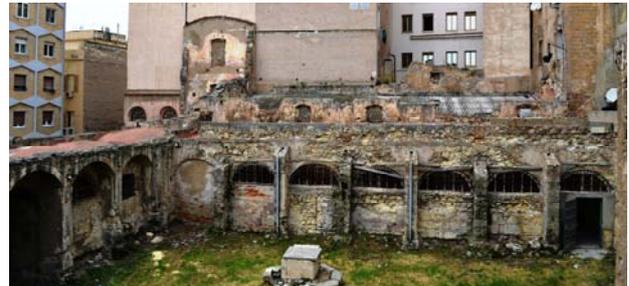
Figure 2: The buildings facing the cloister as seen from the north-east

having been cut in order to open a new street in the middle 20<sup>th</sup> century (Figure 2).

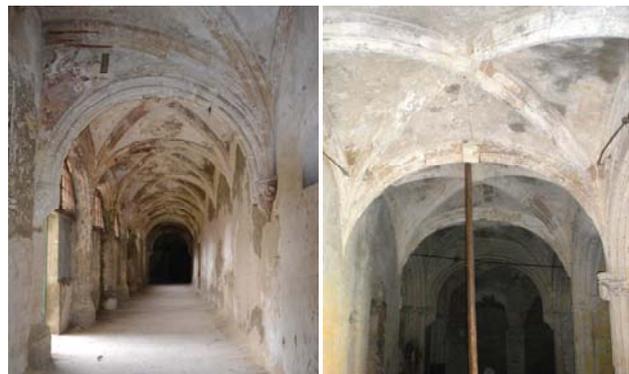
Figure 3: Detail of the western side and interior of the eastern one facing the cloister

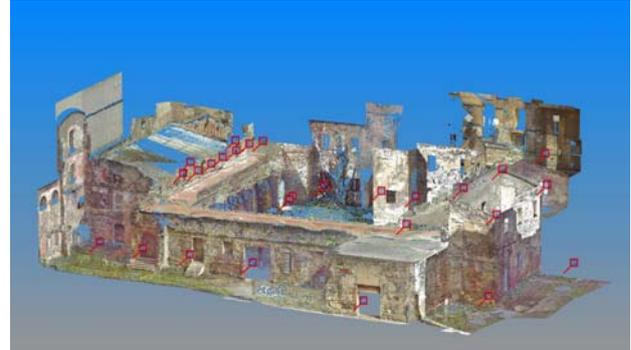
Figure 4: Positions of the outdoor scans in the survey of the St. Francis cloister

The Figure 4 shows the positions of the outdoor scans performed both on the ground level and on the floor.

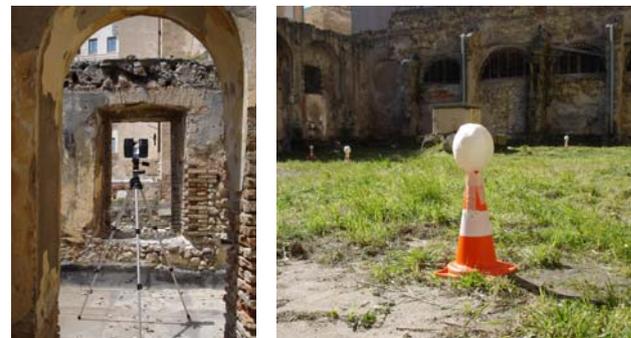
Figures 5 and 6: Outdoor scan. Signals for the georeferencing of the point clouds

During the scans, a number of signals were positioned in the inner and outer court (Figures 5 and 6), to be used in the georeferencing phase of point clouds. The coordinates of the signals were surveyed with a RTK (real-time kinematic) GPS survey in the ETRF2000 reference system (with geoid heights). The differential corrections were supplied by the SARNET permanent station network ([www.sarnet.it](http://www.sarnet.it)).

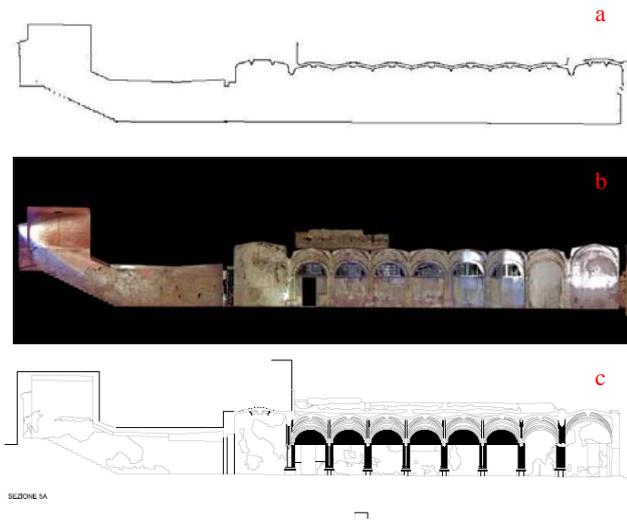
Figure 7: a) A vertical section generated by the software; b) an orthophoto generated by the software; c) a vertical section restituted by an operator with the support of the orthophoto

The Figure 7 displays an example of section and orthophoto automatically extracted from the software and the same section after manual editing.

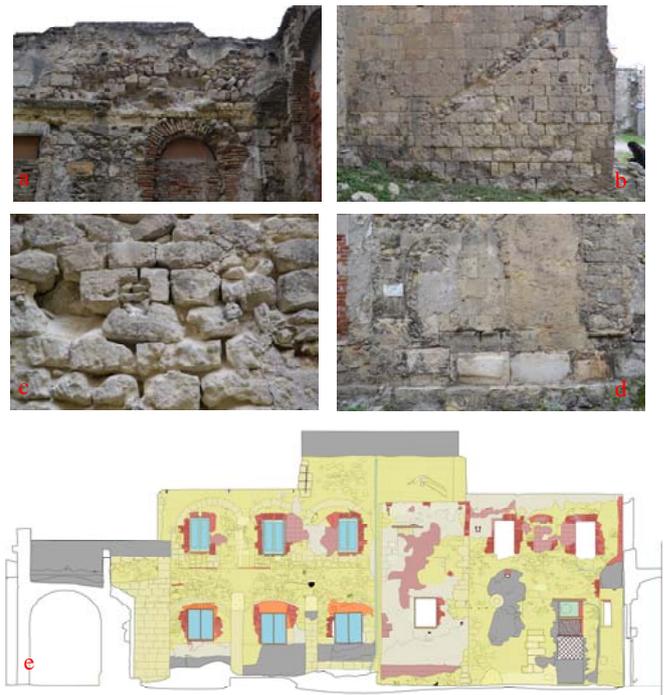
Figure 8: Stone materials used in the building: a) b) c) walls built in “pietra cantone” ashlar and rubble; d) “pietra forte” bossed blocks; e) the north facade with the mapping of materials (yellow “pietra cantone”, grey “plaster”, red “solid brick”, orange “hollow brick”, pink “painting”)

The cloister is built with carbonate rocks of the Oligo-Miocenic series, surfacing in the hills on which Cagliari is built, and commonly known as “pietra cantone”, “tramezzario” and “pietra forte”. The stratigraphic sequence of this area from bottom to top comprises the “pietra cantone”, i.e. a limestone, sometimes argillaceous, with color varying between cream and yellow, with abundant remains of macrofauna (bryozoa, lamellibranchia, etc.) and microfauna (globigerina, globorotalia, etc.), very soft, hygroscopic, easily attacked by external forces. Its physical-mechanical properties limited its use to walls refined with plaster and architectural ornaments; the “pietra forte”, an organogenic reef limestone in facies of bioherma and biostroma, with copious organogenic remains of mollusca, algae and foraminifera, very compact, generally white in color. Utilized from the Roman times to the early sixties of the 20<sup>th</sup> century for its excellent physical and mechanical properties, it was used in the visible works and to build portals, frames, columns, pilasters, etc. The materials forming the load-bearing structure of the cloister are shown in the Figures 8 and 9.

With the help of the orthophoto extracted from the laser scanner survey it has been possible to provide an analytical distribution of the material types through a graphical restitution of the survey (Figure 8 e). As evidenced by the maps, the cloister is built almost entirely with squared ashlar blocks and rubble masonry in “pietra cantone” (Figure 8 a-b-c) with rare blocks of “pietra forte” (Figure 8 d).

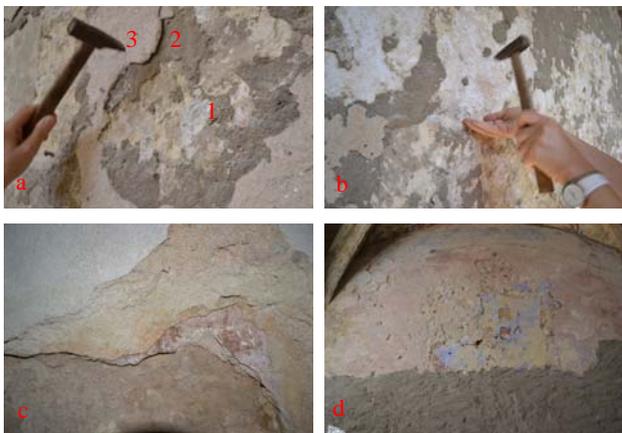
Figure 9: a) Sampling the different types of plaster found in the structure; three layers of plaster are recognizable (1 white, innermost, on wall; 2 dark gray, intermediate; 3 light gray, outer); b) detail of the oldest plaster layer; c-d) consecutive layers of plaster, up to 1 cm thick, placed on older layers, often still carrying the original paint

The cream-colored mortars are generally very degradation, with low cohesion and similar to the oldest white plaster (Figure 9c). They are limes with carbonatic binder and quartz-feldspar aggregate, with copious carbonatic fragments and fossil remains.

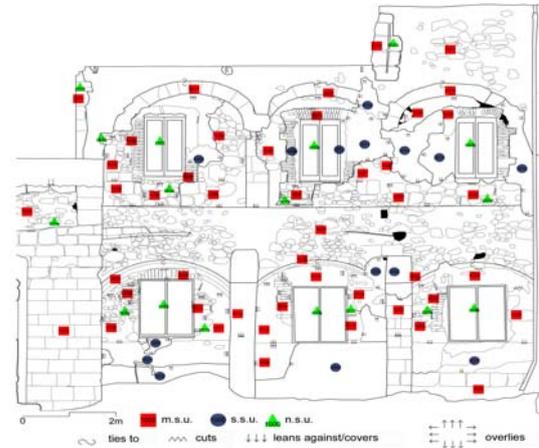
Figure 10: Detail of the north facade, stratigraphic analysis of the structures

In detail, the stratigraphic method was divided into three main phases (Figure 10). The first-one consisted in the identification of the stratigraphic units, as follows:

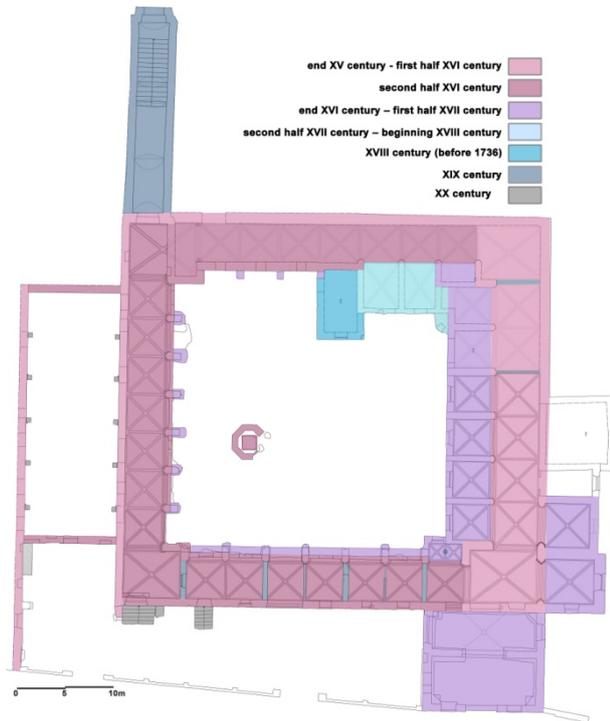
Figure 11: Dating hypothesis of the complex

was not possible to obtain an absolute chronology, but on the basis of the relative one, we were able to associate a temporal interval to each identified phase. In detail, following this investigation, it has been possible to hypothesize that the complex was built in subsequent phases, some of them very close to each other (Figure 11).
