INTEGRATED TECHNOLOGIES FOR SURVEYING ARTEFACTS DAMAGED BY EARTHQUAKES. APPLICATION OF ALL-IN-ONE LIDAR TECHNIQUES IN THE CITY OF L'AQUILA

P. Clini^{a,*}, R. Quattrini^a, F. Fiori^a, R. Nespeca^a

^a DICEA, Dept. of Civil and Building Engineering, and Architecture, Polytechnic University of Marche, Ancona, Italy - (p.clini, r.quattrini, r.nespeca)@univpm.it, f.fiori_f@libero.it

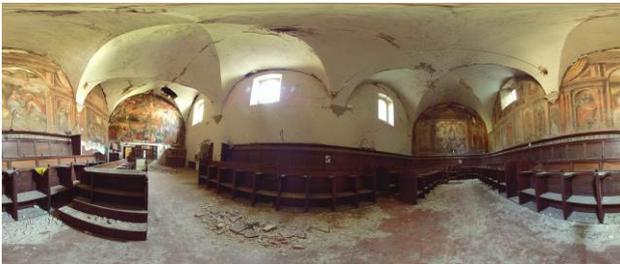
Figure 2. Overview of the choir of the Beata Antonia's monastery, shot using a Leica C10 laser scanner.

The first case study that will be discussed is the Beata Antonia's monastery in L'Aquila (figure 2).

Located near the historic town centre, the monastery preserves its historical architecture. It consists of four oblong buildings that surround the central cloister. The north wing was demolished in 1941 and the reconstruction has no architectural value, while the fourteenth century wings to the east and west have been preserved and the fifteenth century south wing houses the church and the choir. The interior is divided into two distinct areas, one reserved for the nuns and the other for the faithful. The partition wall, above the altar, shows frescoes by Paolo Cardone dating back to 1586. The entirely frescoed choir, however, consists of ninety-seven stalls, the work of Milanese artists of the early sixteenth century. After the earthquake of L'Aquila, a damage evaluation and survey report was prepared by the deputy director for the Protezione Civile, denouncing an alarming situation and the presence of severe damages that were close to causing a collapse of the facade and the vaults of the choir and church.

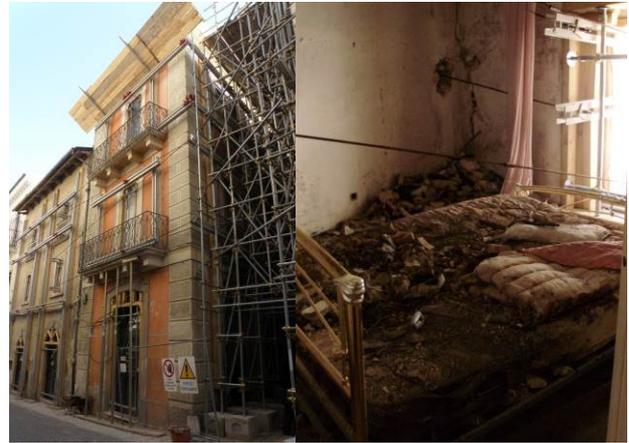
Figure 3. Photograph of a portion of the main facade and the invasive scaffolding put up to allow safety work on the side elevation (left). Photograph of an interior room in which part of the small roof vaults collapsed (right).

demolished to avoid its imminent collapse. The exterior situation showed an inaccessibility due to temporary scaffolding to allow safety work and difficulties in using instruments (photogrammetry and scanners) due to restricted workspace in the surrounding roads. Access to the interior was greatly hampered by the temporary scaffolding put up to allow safety work or even not allowed near the areas that had collapsed (figure 3).

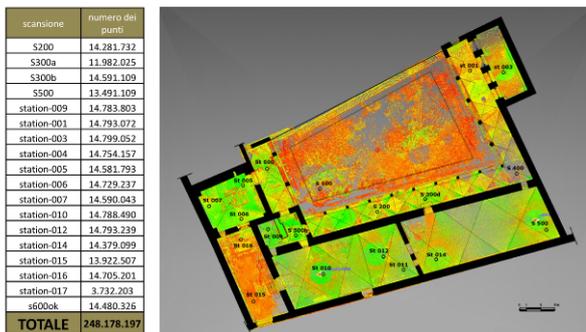
Figure 4. Positions of the stations and the number of points captured for the Beata Antonia's monastery.

In the case of the monastery, the acquisition phase saw, first and foremost, the study of the scanning workstations so that all the spaces that could be reached would be covered. It was decided to carry out free scans, as shown in the plans (figure 4).

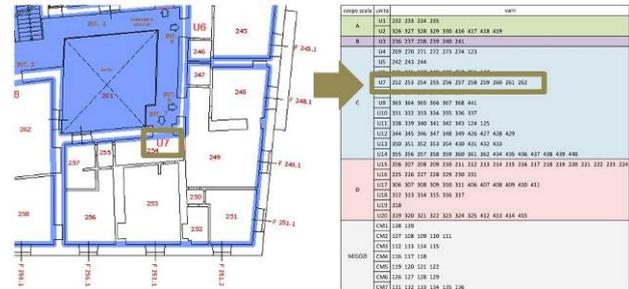
Figure 5. Organisation and division of the city block's housing units and the subsequent numbering of rooms.

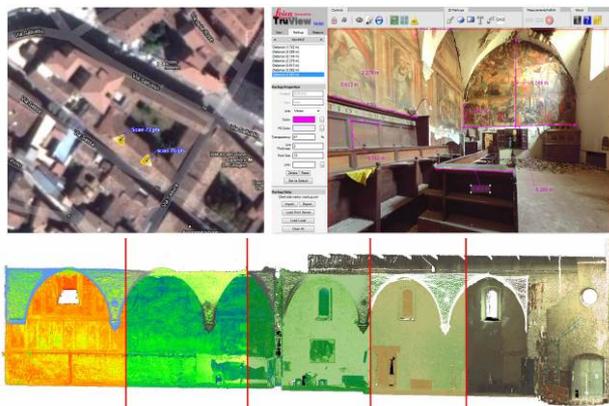
Figure 8. TruView platform built using Cyclone software (above). Composition of reflectance maps (below) (software: Cyclone).

More reflectance maps were generated by varying the display parameters (figure 8). Their comparison has allowed us to identify changes in the color and in the surface roughness, which show the presence of damage to the surface, otherwise not visible. This first analysis can guide subsequent investigations more specific.

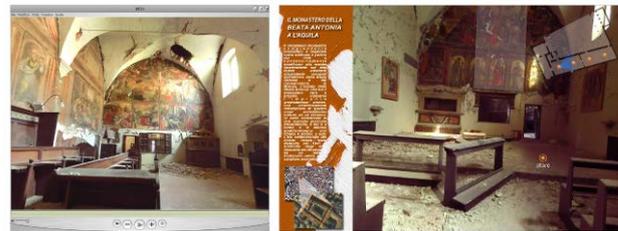
Figure 9. Browsing using spherical panoramas and screenshots of the web-based virtual tour created for the exploration of the areas and the consultation of additional metadata (software: Pano2VR, Tourweaver).

Enriched by information and investigations, they allow the creation of web-based architecture in which the user moves through architectural spaces using hotspots that connect one panorama to the other on a path on which, as well as having the perception of the surrounding space, a metadata base is available. Documentation and communication of cultural heritage in open source environments are ideally suited to these tools (figure 9).

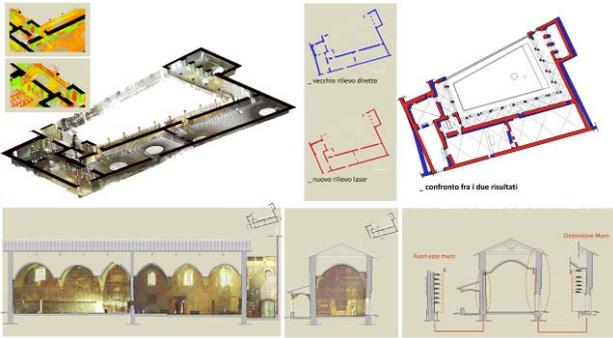
Figure 10. 2D drawings: planimetry and comparison with the previous traditional survey (above) (software: Cloudworks, Autocad). Sections and assessment of deformations (below) (software: Cloudworks, Autocad).

In the case of the monastery, the point cloud managed in this way ensured the completeness of the two-dimensional and 3D drawings (figures 10-11).

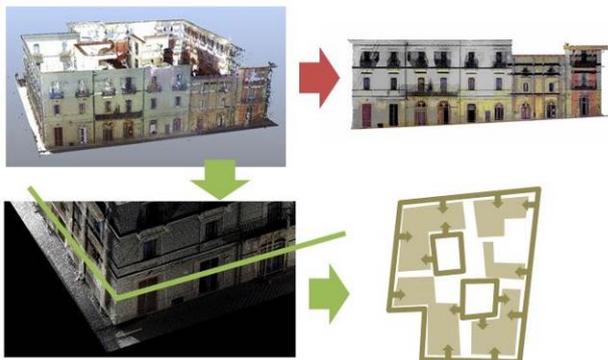
Figure 12. From the discrete model. Extrapolation of orthophoto for the restitution of 2D drawings and slices for the assembly of the direct interior survey (software: Scene).

While for the city block, this represented the initial restitution phase of the traditional interior survey. By connecting through openings or exterior coordinate points, the housing units surveyed individually were linked to the exterior perimeter so as to reconstitute the unit volume (figure 12).

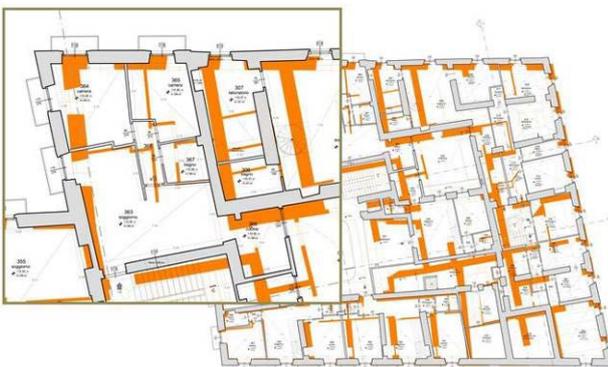
Figure 13. 2D drawings: planimetric comparison with the previous traditional survey (software: Autocad).

The spread of the error was therefore mitigated and only reflected in the individual units (figure 13).

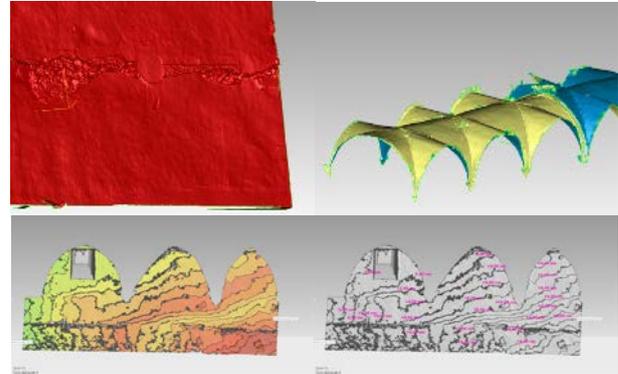
Figure 14. 3D models: mathematical model with mesh surfaces of a wall and the vaults. Map with contour lines that describe the deformations in the wall (software: Geomagic).

The scanning resolution setup was 1cm to 10 m. The expected density of the point cloud is capable of describing the artefact and its state of damage (figure 14).

controlled by an operator, including a filtering stage for noise reduction and decimation that ensures that the file is easy to manage. The high number of acquired points generated a particularly dense mesh that perfectly describes the modelled elements, so as to be an invaluable tool for restoration. An example of its application is a map with contour lines on the wall in order to detect vertical deformation (figure 14).

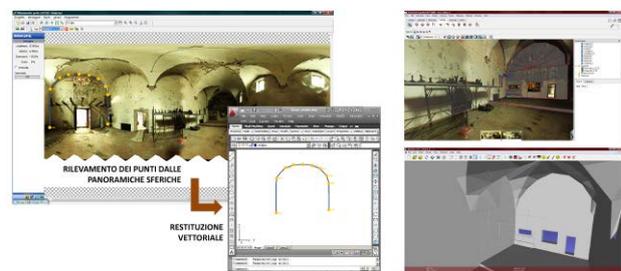
Figure 15. 3D models: extrapolation of spherical panorama vertices by spherical photogrammetry (right) and modelling using image modeler (left) (software: Create Point, Crea, Sphera, Image Modeler).

Other similar software allow the management of panoramas and the creation of 3D models which are less precise, but faster, as in the case of Image Modeler. Geometries become inevitably more simplified and the projection of the image onto the solids generated is very powerful, which finds good use in dissemination. The advantages offered regard the simplicity and speed of realisation and the direct correspondence between photographs and models, but at the expense of metric accuracy and the meshing of curved surfaces (figure 15).

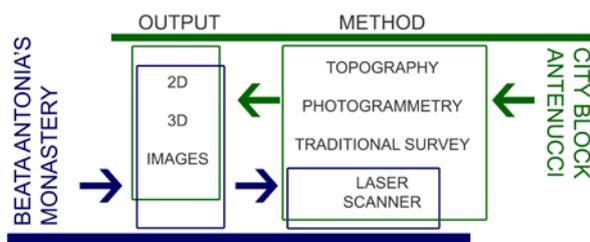
Figure 16. Methodological workflow of the two case studies.
