FINDING THE DISPLACEMENT OF WOOD STRUCTURE IN HERITAGE BUILDING BY 3D LASER SCANNER

KEY WORDS: Heritage buildings, structural displacement, 3D scanners, wood construction, preservation

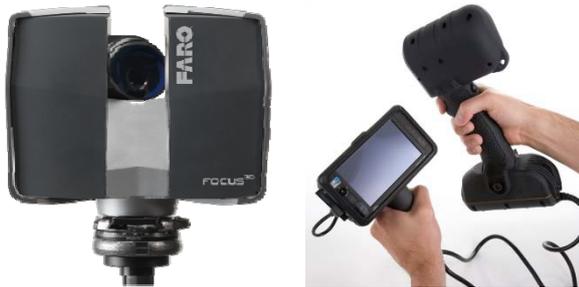
Figure 1. Common 3D laser scanner for fast and exact indoor and outdoor measurements in three dimensions

pixels and quicker scan times, resulting in highly detailed 3D data. 3D laser scanner technology was developed for high accuracy (maximum 0.05mm and average 2mm), therefore exact indoor and outdoor measurements can be taken in under 5 minutes for each scan point, as shown in Figure 1.

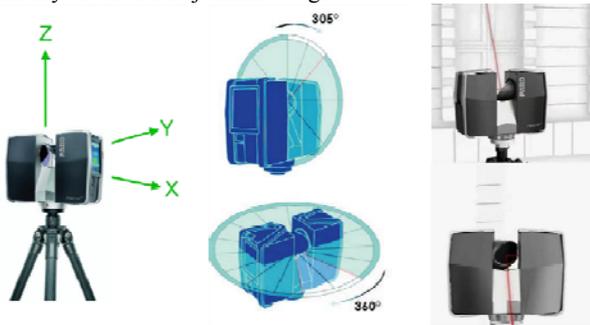
Figure 2. The 3D laser scanner operated for measuring

horizontal and vertical angles [8]

2.2.1 Operation planning: Considering the scan accuracy of three dimensional scanning, survey markers should be “Sphere” to avoid axis mapping mistakes and to be the boundary marks for automatically mapping point clouds. At least 4 survey markers (spherical points) are used in a normal field scan and they are also important reference points in the 3D model building process and structure displacement analysis. The survey markers are usually setup in corners and angles are formed at each segment during the planning stage before the field scanning, and the operated method is similar with total station theodolite in closed traverse survey, the only one difference is survey marks in “Sphere”. Laser scanning works by transmitting a laser to an object and measuring the reflected laser to calculate the coordinates via the tilt angle, distance and operation time. Every reflected coordinate and color hue is then recorded as a point cloud. The 3D laser scanner scan angle in horizontal is 360°, in vertical is 300°, and the distance between the scanned object and instrument is around 0.6-120m, as shown in Figure 2.

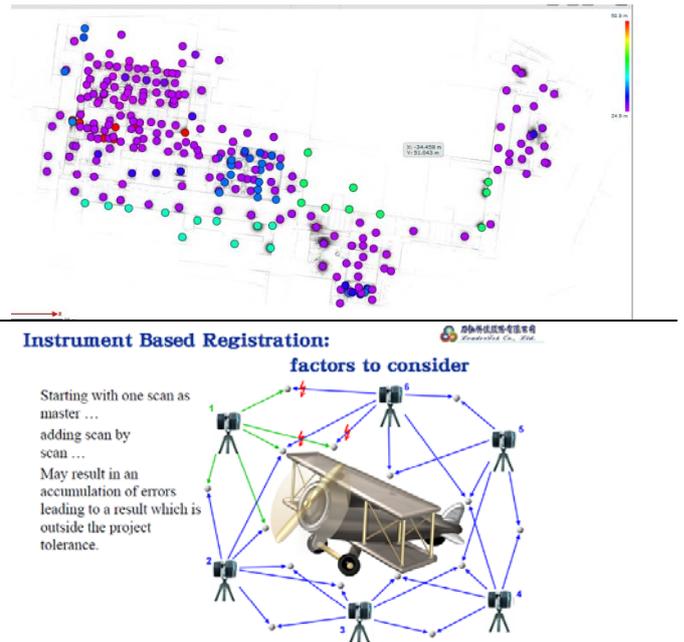
Figure 3. The operation process with survey markers planning [8]

2.2.2 Operation process: The first step in the field scan is setting up the spherical points, as shown in upper Figure 3; the second step is placing the 3D laser scanner at the start point and checking the alignment point and level; the third step is scanning whole object following the planned survey points, as shown in lower Figure 3; after scanning, photos are taken by a digital camera inside the 3D laser scanner at each scan point and the exposure values are checked to ensure photo balance; the fifth step is moving the instrument to the next scan point and repeating the above five steps to finish the closed traverse survey for whole object scanning.

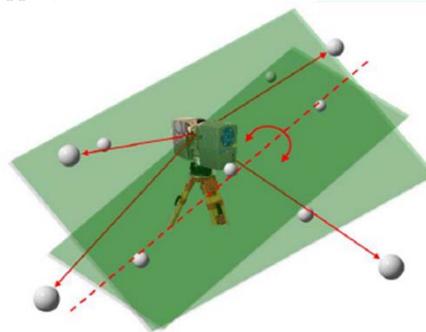
Figure 4. check the relationship of sighting between instrument and every spherical point

2.3.1 3D Scanning data check: After field scanning, the scanned results are transferred into point cloud coordinates and the 3D digital model is created with the coordinates. The scanned results are usually checked in the following steps, (1) check the relationship of sighting between instrument and every spherical point, as shown in Figure 4, (2) the accuracy is quickly checked by scan results via computer software, as shown in Figure 5, (3) total mapping errors in whole spherical points should be under ± 1 cm, the total accuracy is higher when the mapping errors are small.

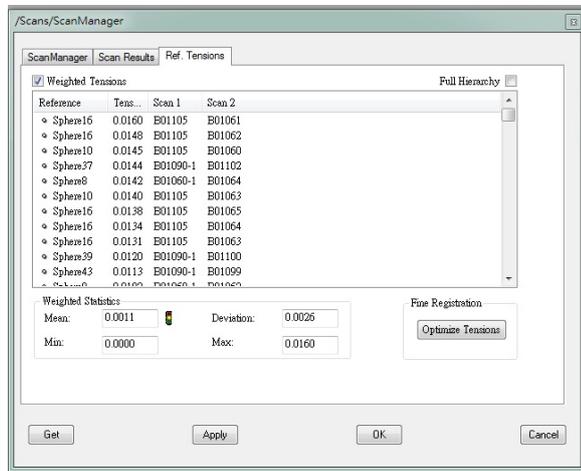
Figure 5. the accuracy is checked by computer software

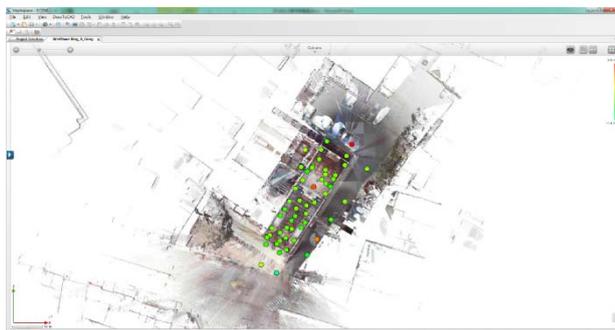
Figure 6. The scan points in field site

The first step is drawing the plan and marking the positions of the 3D laser scanner and the spherical points (the referred points) according to their accuracy and visibility, especially in corners and turning points, as shown in Figure 6 and Figure 7. The second step is setting the marked spherical points by the planning and settling the 3D laser scanner with alignment points and level. The third step is scanning from the back spherical

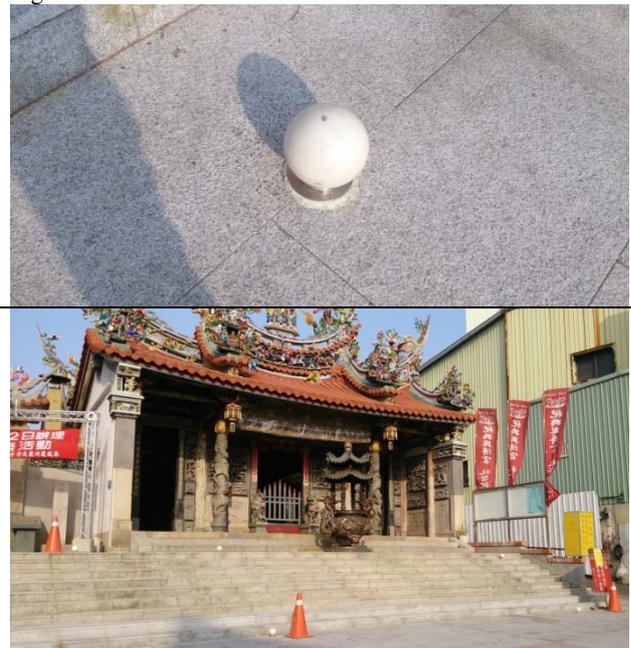
Figure 7. The spherical point and the setup positions in the site

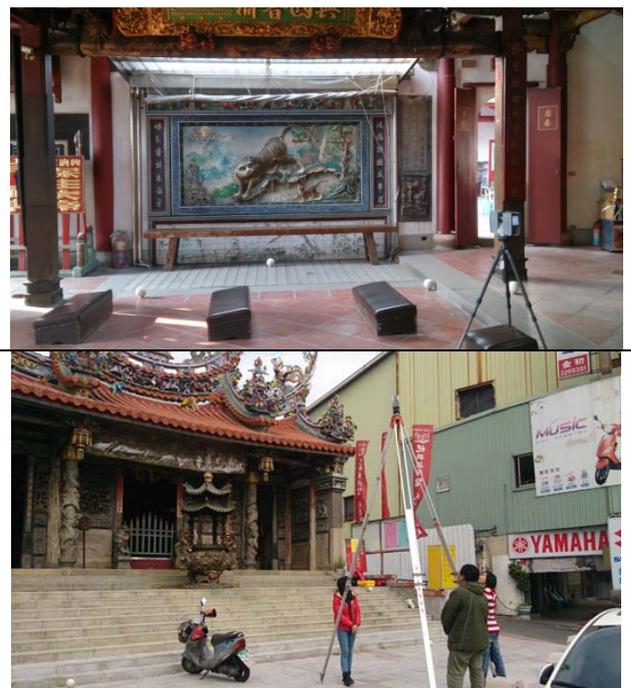
Figure 8. The instrument operation process

point to the front spherical point, and moving one by one to the next scan points, as like closed traverse survey method in Figure 8.

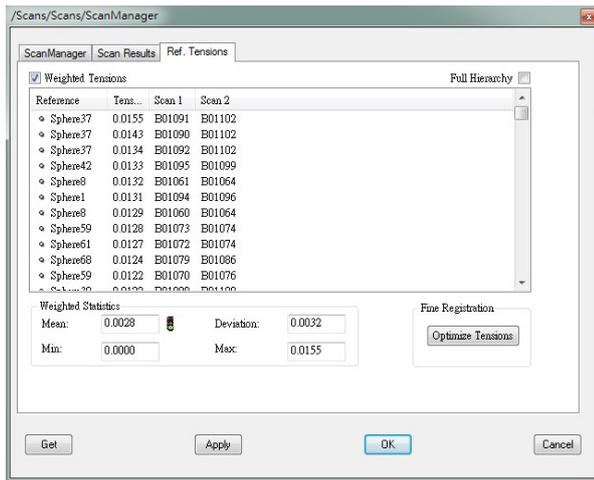
Figure 9. Accuracy calculation by the filed scan results

During the whole field scanning, the accuracy was checked by scan results via computer software, as shown in Figure 9. The accuracy error analysis steps followed section 2-3-1 in this article, and the total error should be under ± 1 cm. The average scan error in each scan point is 1.1mm and the average point cloud error is 1.6 cm in this field scanning result. After confirming the accuracy under the reasonable errors calculation, the unrelated point clouds should be deleted by referring the digital photos to build the 3D model, as shown in Figure 10.

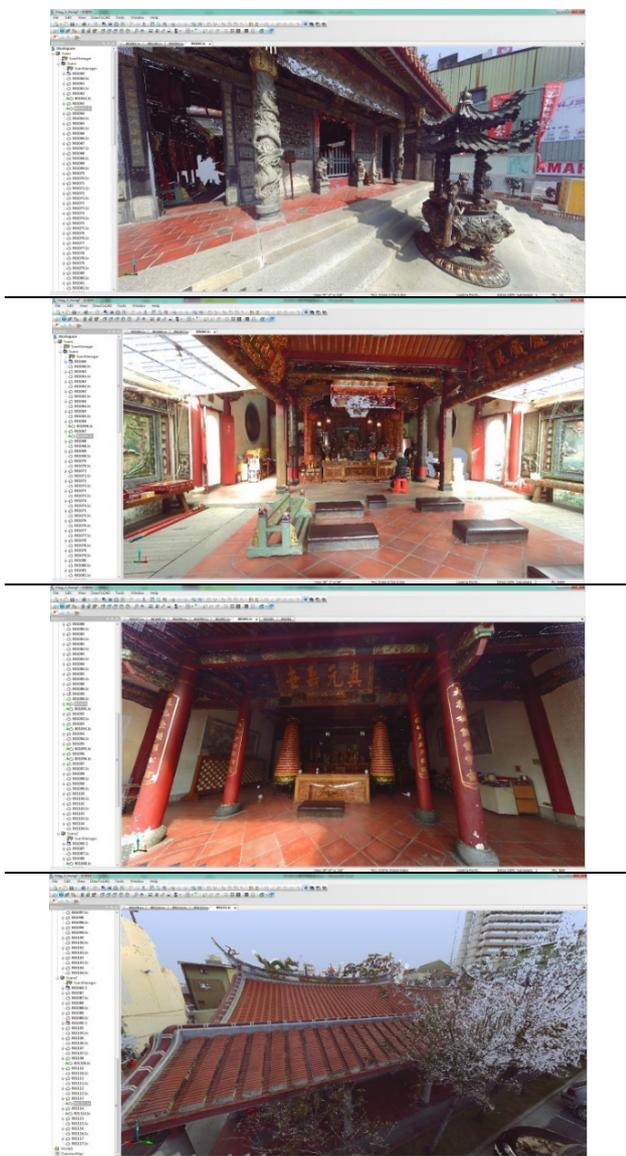
Figure 10. 3D models built by point clouds and digital photos

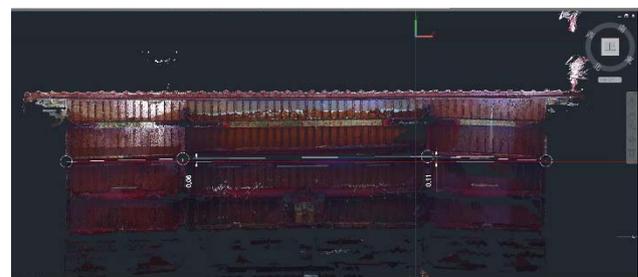
Figure 12. A horizontal line cross the roof structure referred by the datum line in the front hall

To understand the details of the displacement in the front hall, this study checks the connections of roof structures and columns on the roof plan, then makes a horizontal line as the datum line from the spherical points (the referred points). Drawing a horizontal line across the roof structure referred by the datum line, there are some deflections between the left junction and the right junction, and the vertical deflections between the horizontal line are 0.06m (right, tiger side) and 0.11m (left, dragon side), as shown in Figure 12. Since there was significant displacement on the dragon side junction, the 3D model was used and the view of the area was zoomed in to check the relative position between column and plinth. The result shows the offset between the centre line of column and plinth is 0.15m, as shown in Figure 13 (scanned in 2013). This study asked the scanned 3D model in 2006 in Figure 14, the offset at the same position is 0.07m in 2006. Comparing the same position between the scanned 3D model in 2006 and in 2013, the offset is from 0.07m to 0.15m, the result shows the deflection is still occurring. When deflection occurs in the same direction and with large displacement, and the deformation angle is larger than 1/15rad [9], the structure will tip and collapse, destroying the cultural heritage. The damage risk is higher for structural members than cracked and peeling paint.

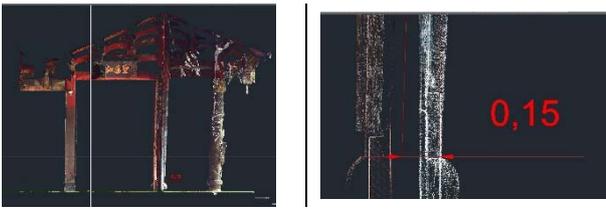
Figure 13. The dragon side column shows the offset between the centre line of column and plinth in 2013

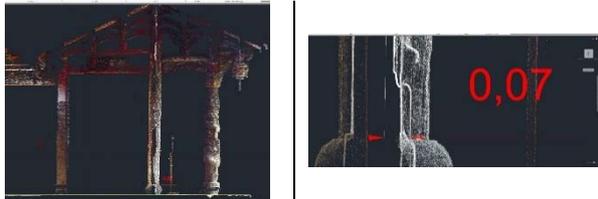
Figure 14. The dragon side column shows the offset between the centre line of column and plinth in 2006
