RECOVERING A COLLAPSED MEDIEVAL FRESCO BY USING 3D MODELING TECHNIQUES

F. Chiabrando^a, F. Rinaudo^{b,*}

The paper presents the results of a reconstruction of the 3D model of a dome and of a medieval fresco, collapsed after an earthquake and now reconstructed in significant portions, to offer to the visitors a possible reconstruction of the lost masterpiece of medieval art. After the earthquake the collapsed dome was replaced by means of a concrete sphere connected with the survived portions of the old dome's timber. The old dome shape and the fresco were virtually reconstructed thanks to a set of historical pictures obtained by Italian, USA and German archives; those images have been calibrated and oriented by using modern digital photogrammetric approach and a realistic 3D model of the old inner surface of the dome has been realised. By using a LiDAR survey the 3D model of the apse and of the dome, has been set up and the boundaries between original and new structures have been reconstructed by visual evidences. The new dome has been virtually erased and the old dome with the fresco 3D model inserted allowing the reconstruction of the apse as it was before the earthquake. This

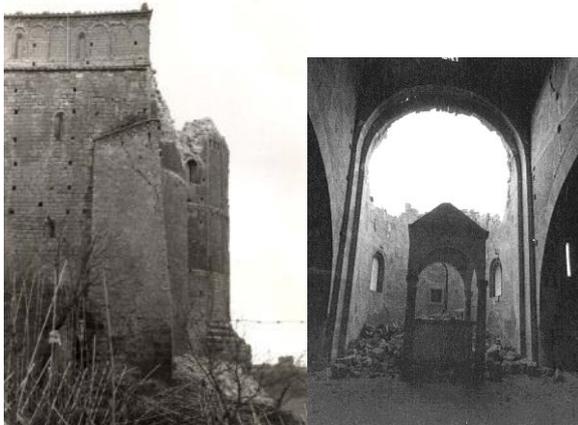
Figure 1. Outside (left) and inside (right) view of the dome after the earthquake in 1971.

The structural elements of the church were not damaged but the apse's dome with a precious medieval fresco was completely destroyed (see Figures 1).

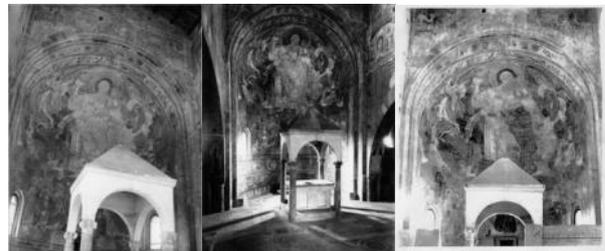
Figure 2. The fresco as it was in 1925 (left – courtesy of ICCD), 1954 (centre – courtesy of ICCD) and 1969 (right – made by Hutzler Max. Courtesy of Research Library, The Getty Research Institute, Los Angeles - 86.P.8)

Unfortunately in the last 70 years before the earthquake the church was completely abandoned and some parts of the fresco was yet lost (see Figure 2).

In the last 20 years all the photographic Cultural heritage pictures (both glass and film pictures) of the official Italian Institutions have been digitized and documented, therefore it was easy to find out all the documented pictures present in Italy about the fresco before the earthquake. The main results were obtained from the Italian Centre of Restoration (ISCR) and Italian Centre of Cataloguing and Documentation (ICCD) archives. Some other international private institutions were involved in order to find out possible stereoscopic images of the fresco: in particular the Library of the Getty Research Institute (Los Angeles - U.S.A.) and the Hirmer photographic archive (Munich - Germany) sent interesting pictures realised some years before the earthquake (see Figure 2).

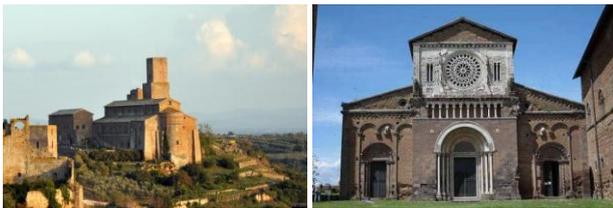
Figure 3: A view of the Civita Hill (left) and the main facade of the Basilica di San Pietro (right).

After the earthquake the Italian authorities financed a simple protection of the ruins by inserting a concrete spherical dome to protect the apse and started a series of restorations of the whole complex of the Basilica (the church, the bishop's palace, two medieval towers. See Figure 3).

Actually the San Pietro site is composed by different structures with heterogeneous architectural styles realized over some centuries for historical reasons: the Basilica, two medieval towers and a palace used in the past as Bishop main site. The Basilica is a Romanic style building with three naves: the most ancient nucleus (XI cent. a. C.) is represented by the crypt, which was realized under the actual settlement of the basilica, the apse and the first part of the naves. It is surrounded by the ruins of the ancient Bishop citadel and it is placed on the top of the Civita Hill (Figure 3 left) in a rural area outside the current urban area of Tuscania; the Basilica was the religious center before the gradual abandonment of the area. In the XIII century the Basilica reached the actual shape: the three naves were protracted and the main façade was realized by using a monumental decorative apparatus (Figure 3 right).

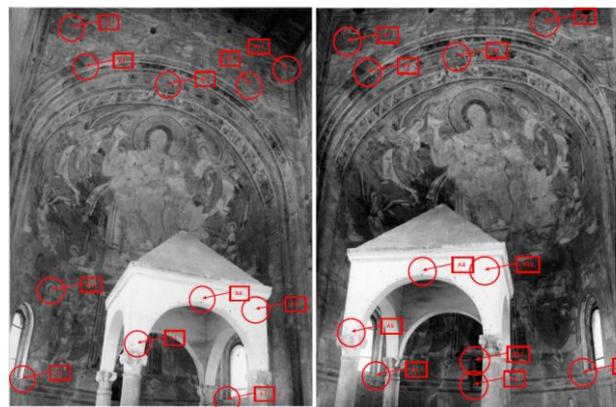
Figure 4. ISCR's images 6172 – 6174 with GCP's used for the self-calibration

Among all the images dating before 1954 just two of them fit all the requirements above expressed (see Figure 4).

For each image 11 GCPs were available but for each image a different set of GCPs was selected by considering the appearance of the points for a good collimation.

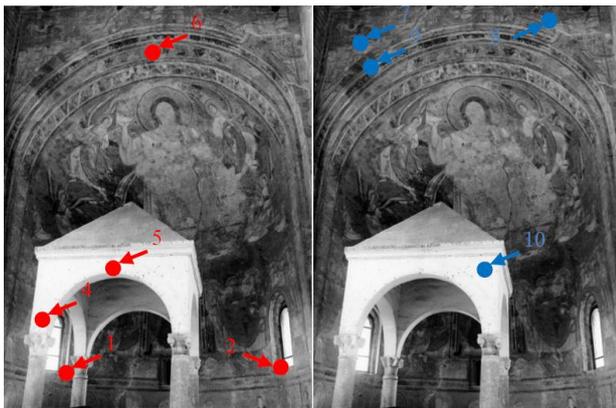
Figure 5. GCPs (left) and CPs (right) used for exterior orientation parameter and accuracy estimations (showed on the 6172 ISCR's image)

The GCPs were selected among all the points surveyed for the calibration of the images: obviously the selected points are visible and well represented for a consistent stereoscopic collimation on both the images. The number of the GCPs was limited to 6 in order to obtain a correct estimation of the exterior orientation parameters by using the least squares approach (a number of solving equations equal to the double of the unknowns). The remaining stereoscopic points on the images was then used as Control Points (CPs) to estimate also the accuracy of the exterior orientation parameters estimation. Figure 5 show the spatial distribution of the GCPs and CPs used in this step.

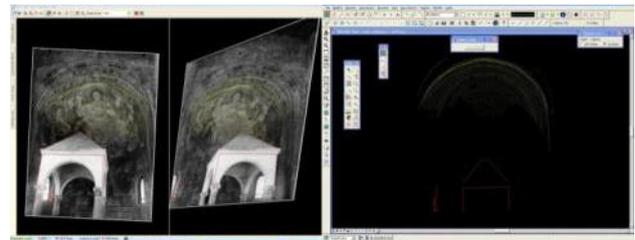
Figure 6. The two oriented images and the graphical results of the plotting of the old surface of the dome

Using the obtained results it was possible to plot the old dome shape by using matching procedures with a huge integration of manual plotting to integrate the results of automatic 3D recovering (Figure 6) (approx.1 point each 5 mm).

The resulting point cloud is of about 4000 points and by using their coordinates a least square interpolation allowed the estimation of the radius of the interpolating sphere and the estimation of the discrepancies of the known points coordinates by considering the sphere as the reference surface (Kalisperakis, 2003; Lerma, 2005). The results can be summarized in that way: the surveyed points of the old dome can be interpolated by means of a sphere with a radius of 3.35 m.

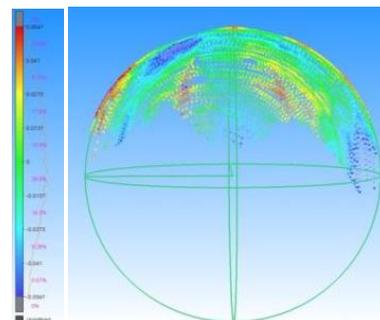
Figure 7. Coloured graphical representation of the discrepancies between the interpolated sphere and the surveyed points.

By checking the distances between the surveyed points and the interpolated sphere the values of the discrepancies range from - 0.051 m up to 0.054 m with a standard deviation of about 0.024 m (Figure 7).

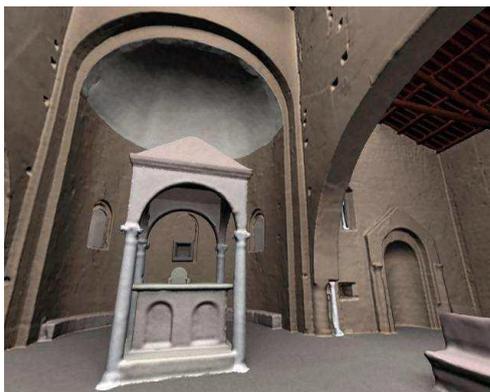
Figure 8. The apse and his surrounding actual shape

The model of the existing apse has been surveyed by means LiDAR techniques (see Figure 8) during the documentation process of the church.

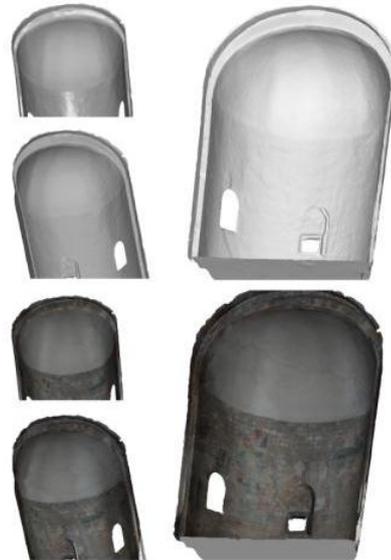
Figure 9. Shaded and textured 3D model of the existing apse

The registration of the recorded point clouds was realized by using the RISCAN PRO software in order to reach an approximate 3D model of all the acquired surfaces (Bohletr, 2005; Bonora et al., 2005; El Hakim et al., 2008). During this phase all the visible reflective targets were employed to give a preliminary solution, than an ICP approach (Bae, 2004; Del Pizzo, 2011; Shutz, 2002; Sharp, 2002) was used to refine the registration. The most accurate survey was performed in the apse part in order to rebuild the shape of this actual part (Figure 8) of the Basilica and moreover for the extraction of the information usable for the reconstruction purpose (Figure 9).

After this first step, following a traditional modelling approach (Lo Turco, 2009), by superimposing the old dome's model to the today's model it was possible to evaluate the parts of the apse that can be considered originals and the ideal line of intersection between the dome and the vertical walls (see Figure 9).

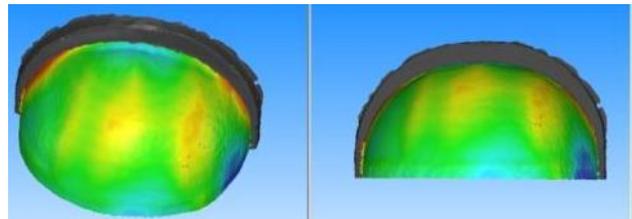
Figure 10. Graphical representation of the differences between LiDAR model and the recovered shape of the dome

coordinate system) and by judging where the old model can be replaced instead the existing one (see Figure 10 and 11).

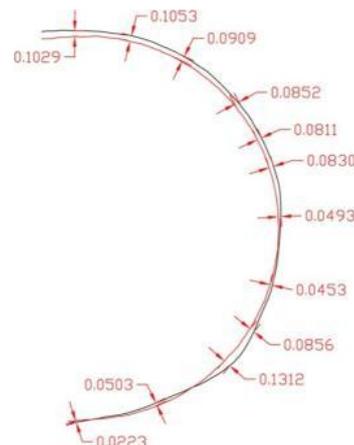
Figure 11. One of the sections used to define the borders of the original parts of the apse and the new dome

This 3D line definition has been performed by generating several sections of the two models (positioned in the same

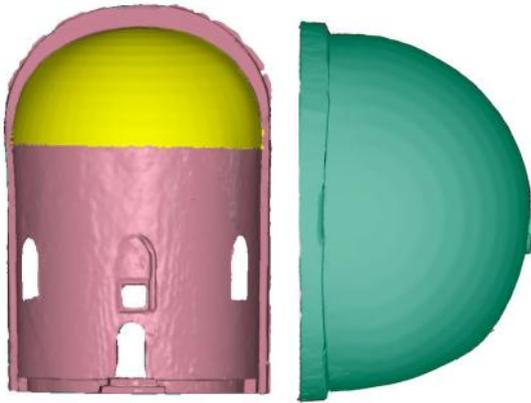
Figure 12. Front view of the existing apse (pink) and historical shapes (yellow) inside the virtual 3D model of the original apse before the earthquake (left), top view (right)

Once the border between old structures and new structures has been defined it was possible to eliminate the concrete dome and the reconstructed parts and to insert the original 3D information coming from the historical images as described in the previous paragraphs (see Figure 12).

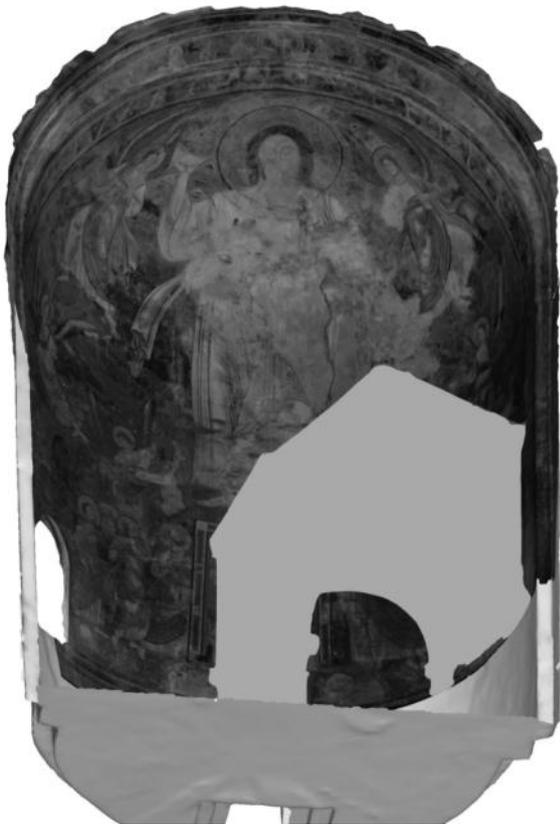
Figure 13. 3D model with texture extracted from the images acquired in 1954 used for the geometric recovering of the no more existing dome.

Finally the images used for the geometric recovering of the old shape has been used to realize a textured 3D model in order to be able to proceed towards the realisation of the 1:1 scale model

of the old dome and to allow the restorers to reproduce some of the possible pieces of the original fresco (see Figure 13).

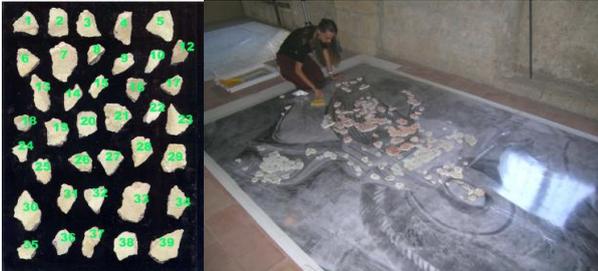
Figure 15. The catalogued fragments and the first mosaicking on enlarged photo (courtesy of ISCR and Werner Matthias Schmid)

The following figures show the fragments after the classification, during the first mosaicking trials by using simple enlargement of the pictures and the 3D 1:1 scale model realized and in the future offered to the visitors to appreciate the old fresco never documented inside the church after the earthquake.

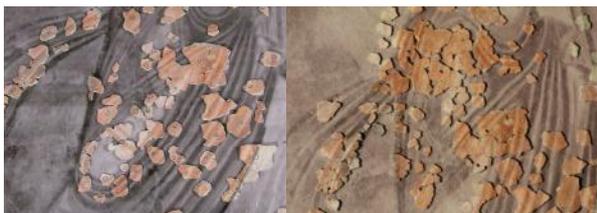
Figure 16. Result of the first mosaicking on enlarged photo and the 3D model at 1:1 scale (courtesy of ISCR and Werner Matthias Schmid)

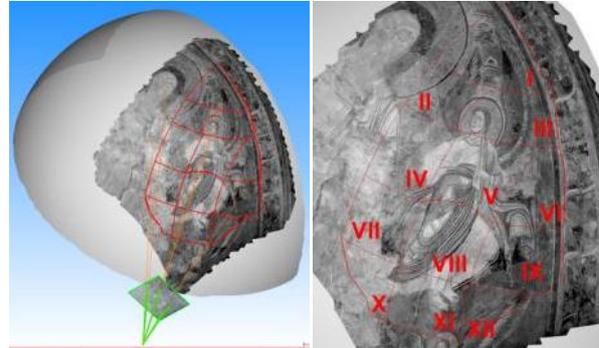
Figure 17 Texturing phase (left) and the 12 different orthoprojected parts (right).

First of all the part was textured with a high resolution image according to the well-known methodology (Rusinkiewicz, 2000; Vu, 2009) (Figure 17 left).

After that the complete angel was divided in 12 parts (Figure 17 right) with a size of 60 cm x 60 cm in order to limit the deformation in the boundary.

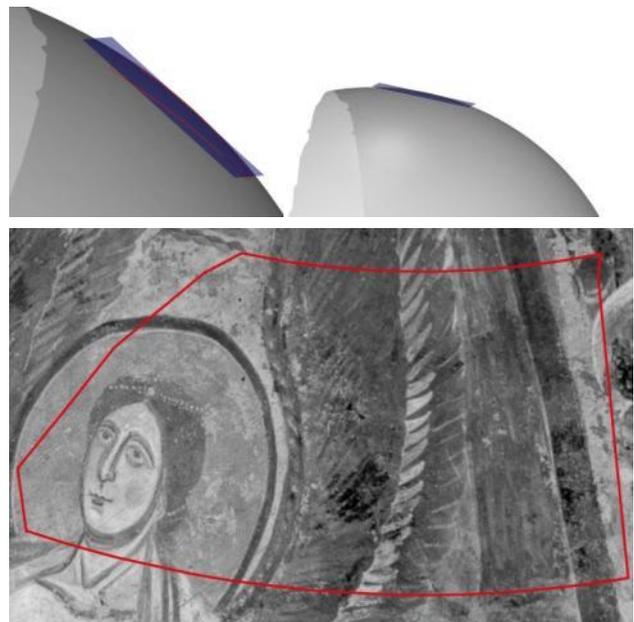
Figure 18. Two views of the extracted planes (above) and orthoprojection of part III (below).

For each portion of the sphere the tangent plane equation was estimated; this procedure has been performed by using the automatic plane extraction command of 3DReshaper (Figure 18 above). Finally, for each portion, the orthographic projection was realized (Figure 18 below).

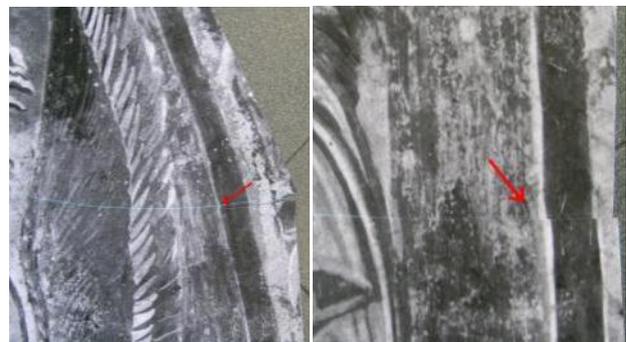
Figure 19. Mismatch during the first attempt

All the theoretical formulation about the orthographic projection confirms, as stated in the previous paragraph, that the results of the process could be achieved without appreciable errors for the mosaicking of the fragments, but overlapping the single orthographic panels some little mismatch were obviously encountered (Figure 19).

The final prints were realized using the TATTOOWALL® system. Some of the afore mentioned mismatches during the final stick on the spherical support were solved and moreover thanks to the masterly hand of the painting restorer the final result appears totally uniform without any error in the parts where two or more areas were connected (Figure 19).

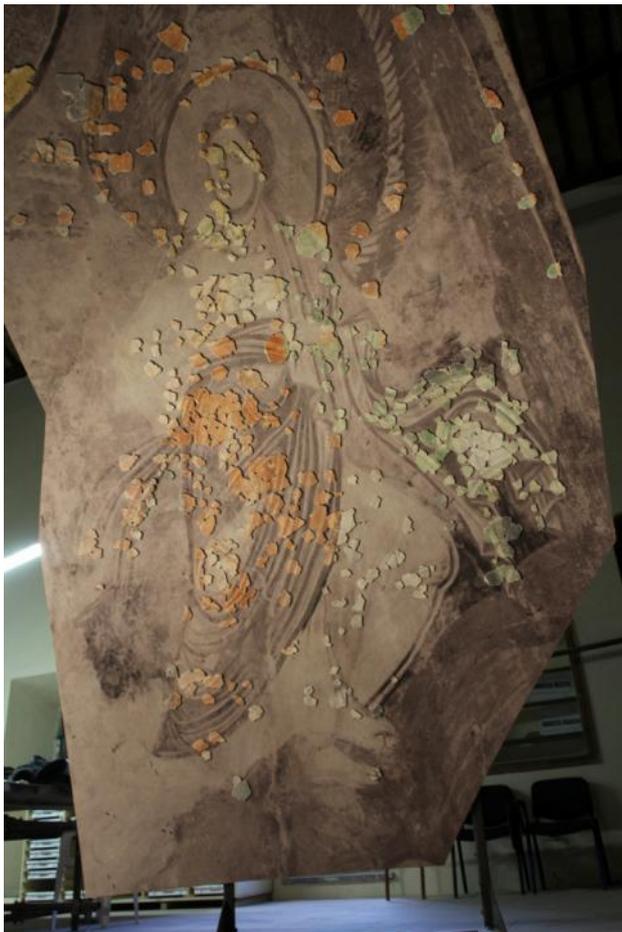
Figure 20. The complete final 1:1 scale 3D model of a significant part of the old dome ready to be presented to the visitors. (Courtesy of ISCR and Werner Matthias Schmid)

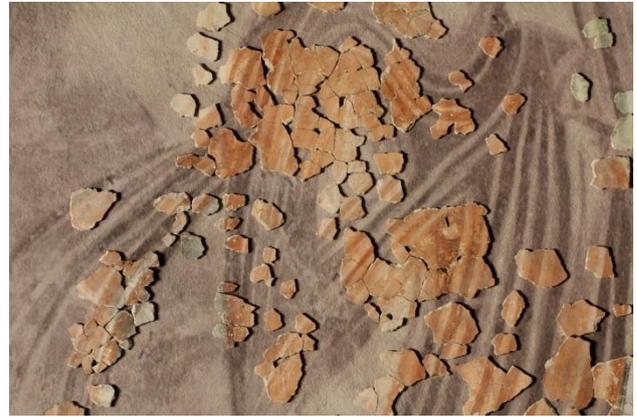
Figure 21. A part of the model where is possible to notice the perfect conformity between the little piece of the destroyed frescos and the achieved support. (Courtesy of ISCR and Werner Matthias Schmid)
