MULTI-SENSOR DOCUMENTATION OF METRIC AND QUALITATIVE INFORMATION OF HISTORIC STONE STRUCTURES

E. Adamopoulos ^{a,*}, E. Tsilimantou ^a, V. Keramidas ^a, M. Apostolopoulou ^a, M. Karoglou ^a, S. Tapinaki ^b,
C. Ioannidis ^b, A. Georgopoulos ^b, A. Moropoulou ^a

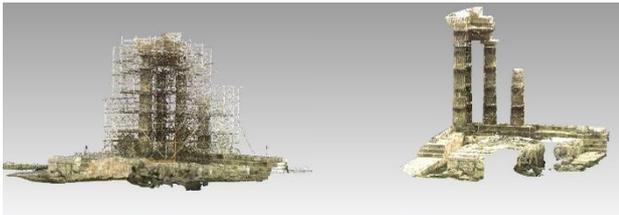
Figure 3: Point cloud of TLS before (left) and after (right) the removal of noise; West façade

After the noise was removed, an attempt was made to create a three-dimensional surface for the whole monument. The density of the information and the concealment problems created by the scaffolding in combination with the scanning angles and the complex morphology of the object, did not allow the complete modeling of the monument, the effort of including patches of photogrammetrically produced models and therefore it was decided to produce only 2D derivatives. The drawings were created by extracting thin sections of the 3D point cloud and connecting the points, by drawing directly in 3D (Autodesk Recap) and by filling in with photogrammetrically produced sections, points measured individually and details subtracted from architectural plans.

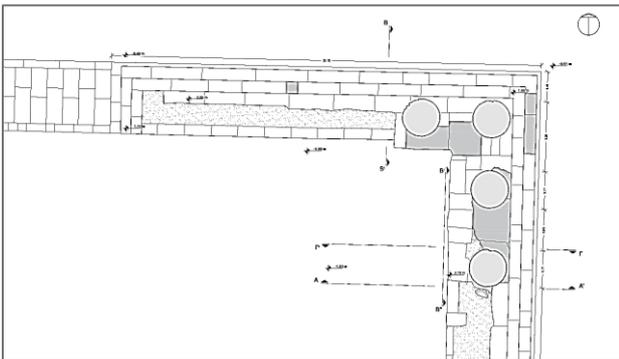
Figure 4: Excerpt of horizontal section drawing

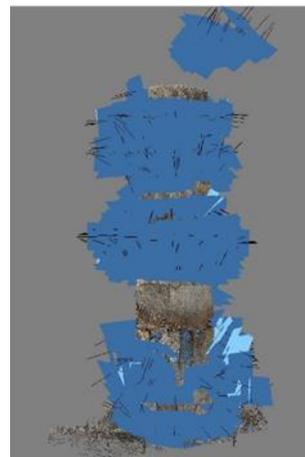
Figure 5: Camera positions estimation and sparse point cloud generation

In total 640 images were taken. The shots were conducted with a focal length of 16-34 mm (wide angle) focal length lens. Most images were taken with a fixed focal length of 16 mm, from a distance of 1-1.5 m for the side surfaces and about 3-3.5 m for the top of the column. The pixel was 6.4 µm, so the GSD was 0.4-0.6 mm for the side surfaces and 1.2-1.4 mm for the top. The detail images were taken with a fixed focal length of 34 mm from up to 0.5 m, i.e. the GSD for that particular set of images was < 0.2 mm. In this application where the final precision of the orthoimages corresponded to the 1:25 scale, the GSD had to be < 2.1 mm, (applied to all distances and focal length combinations). For the georeferencing and the scaling of the 3D model, 27 pre-signed points were placed, suitably scattered in a way to be visible from at least one geodetic network station. The steps of the reconstruction are presented with Figures 5 – 8.

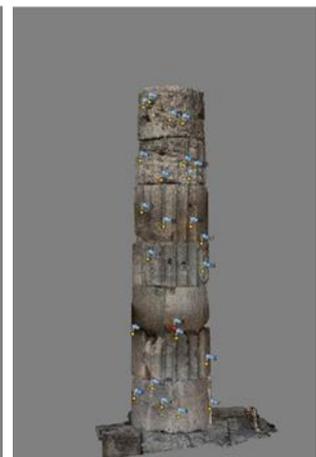
Figure 6: Dense point cloud generation with predefined points for georeferencing and scaling

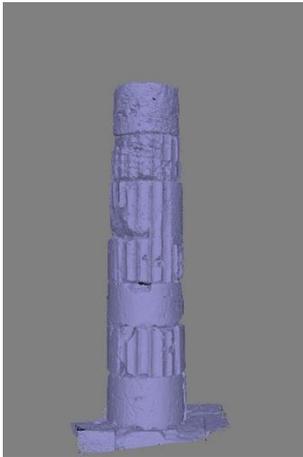
Figure 7: Mesh (surface model) generation

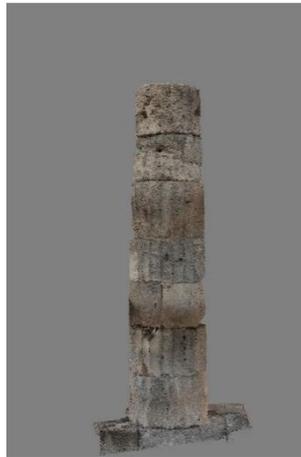
Figure 8: Texture generation

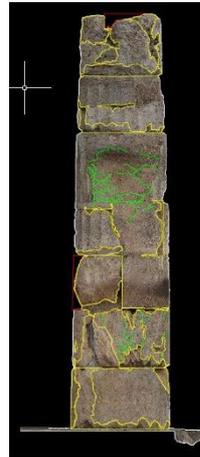
Figure 9: Cracks and loss of materials recording

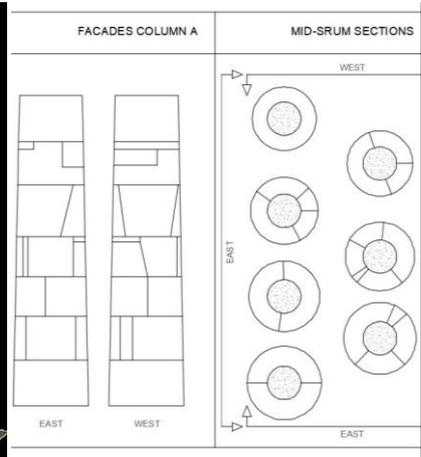
Figure 10: Faces of the south column and mid-drum sections; plans for assisting FEM modelling

The structural documentation was conducted in successive steps. At first an identification of the bearing and non-bearing elements and their geometry was attempted, taking into consideration the existing knowledge for the construction of temples of the same order and chronic period and, previous architectural and photographic documentation. Secondly cracks and areas with significant loss of material were recorded. A supplementation of architectural and surveying drawings followed, with information regarding the materials, the construction techniques, the loads and the mechanical damages. An initial assessment of the current state and the, possibly, necessary repairs or reinforcement operations was made, in combination with the NDT & E for the mechanical characteristics (hammer test). These measurements were conducted on each side and each drum of the south column with 10 cm intervals. The results of the structural documentation were combined with those of the geometric recording to produce 2D drawings that depicted the geometry of the bearers, in order to facilitate Discrete Element Modelling and analysis.

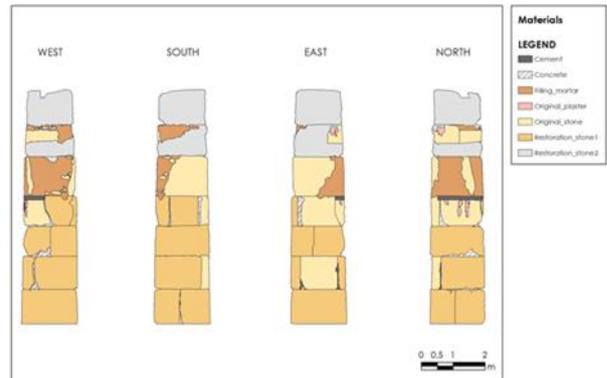
Figure 11: Thematic mapping of building materials

Building materials and decay patterns were classified according to spatial properties and physico-chemical characteristics, and were represented by a different layer and displayed by a different color. Thematic maps were produced not only for the materials and decay (Figures 11, 12), but also for the NDT & E (Figure 13). Data retrieval was executed using relational operators to compare feature values associated with spatial data. Boolean operations were used to access and manipulate various entities and attributes (Figure 14).

Materials identification, initially made by visual observation, was verified by classification based on the characteristics attributed to each spatial entity. The building materials that predominate are the stones (biocalcarene sandstone with poor consistency-microstructure). The original architectural surface (beige plaster) is retained at a very small percentage. Cement mortars have been used in previous interventions widely to complement the geometry, while concrete, used in the column core, becomes visible locally when there is a fragmentation of surrounding materials.

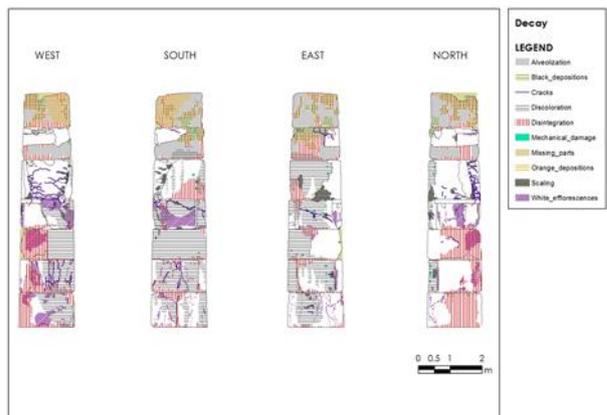
Figure 12: Thematic mapping of decay patterns

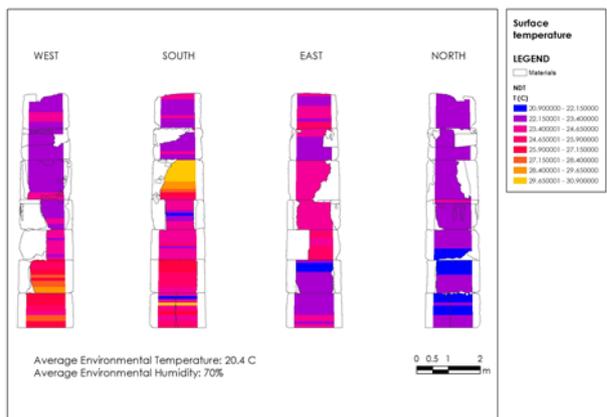
Figure 13: Thematic mapping of surface temperature

The distribution of thermal loads is justified by sun exposure (solar track). Considerable loads are concentrated on the south side of the column and result to cracks and scaling. Extremely high concentrations of soluble salts are located at the north, more exposed to the strong winds (directing from the sea) façade. Disintegration is largely caused by the effects of concrete on the neighboring calcareous materials.

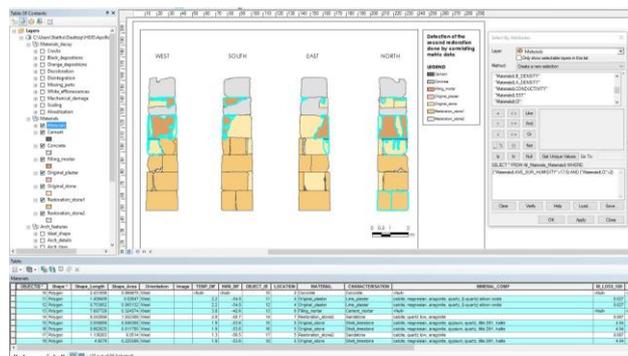
Figure 14: GIS analysis operations on the thematic map of building materials

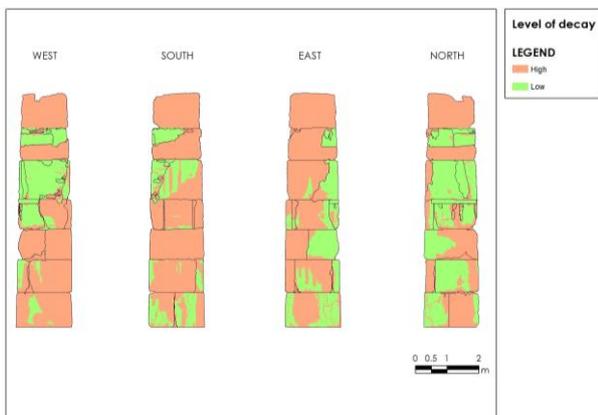
Figure 15: Thematic map of the level of decay (Orange: High level of decay; Light green: Low level of decay)

Regarding the impact of endogenous and exogenous factors, in general, the entire surface of the column is deteriorated; the decay is, to a large extent, particularly intense. Figure 15 demonstrated areas with intense (orange color) and mild (light green color) deterioration.

In the two upper drums, there are extensive depositions and alveolization. Due to the location, hue, surface morphology, and the permanently increased moisture, it is deduced that the depositions are of biological origin (moss and lichens). The rest of the surface is dominated by discolorations and disintegration. These types of decay are more common at the north and west, a pattern that is justified by the usual intense northwest winds that carry the seawater suspensions. On the surface of the column, white efflorescences and scaling appear to a lesser degree.
