RESEARCH ON NON-DESTRUCTIVE TESTING TECHNOLOGY IN CONSERVATION REPAIR PROJECT OF ANCESTRAL TEMPLE IN MUKDEN PALACE¹

This paper, in the form of case study of Ancestral Temple in Mukden Palace, aims to introduce non-destructive testing technology (ground penetrating radar, stress wave, resistograph and so on) and explore an appropriate protection method in the repair project of traditional Chinese wooden architecture.

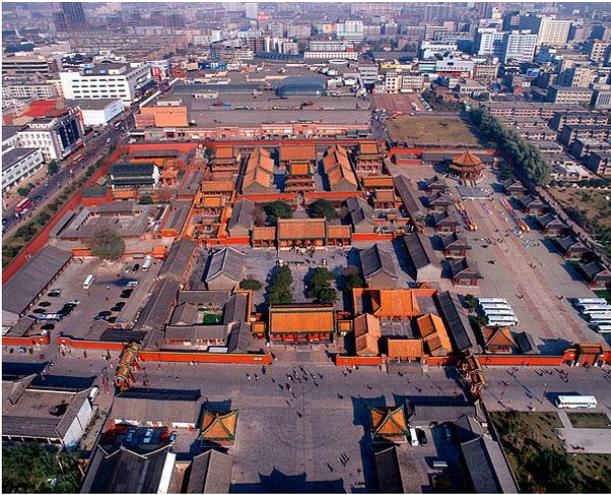
Figure 1. The aerial view of Mukden Palace

Early construction of Mukden Palace began in 1625 by Nurhaci, the founder of the Qing dynasty. In 1631, additional structures were added during the reign of Huangtaiji, Nurhaci's successor. The Mukden Palace was built to imitate Beijing's Forbidden City. However, the palace also shows the cultural characteristics of Manchu and Tibetan (Figure 1)^[6].

Ancestral Temple, located on the east side of the Great Qing Gate of Mukden Palace, is an antique-courtyard-style building (Figure 1). The temple is off the beaten track as it doesn't belong to the main part of the palace.

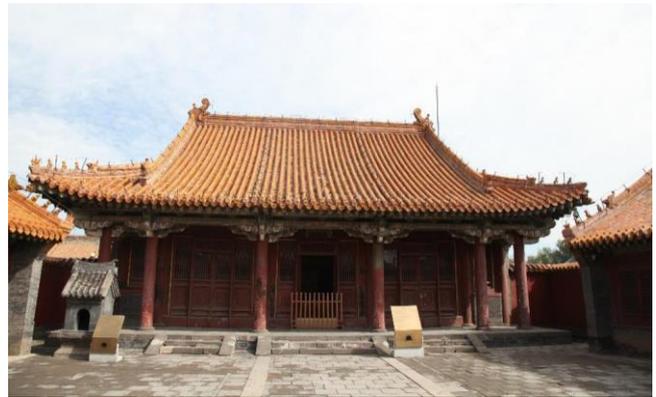
Figure 2 The main hall of Ancestral Temple in Mukden Palace

Ancestral Temple was built on an independent two-meters high platform, and formed a typical enclosed courtyard (四合院). This building complex consists of six buildings: main hall (Figure 2), temple gate (Figure 3), two side halls with one penthouse each (Figure 4). The main hall is an extends five(五间) building with front porch and Xieshan(歇山) roof covered with yellow glazed tiles. To the southwest of the main hall, located the Fen Jin pavilion (焚帛楼), which was used for sacrifice. To the east and west of the main hall, there are two side hall, which are extends

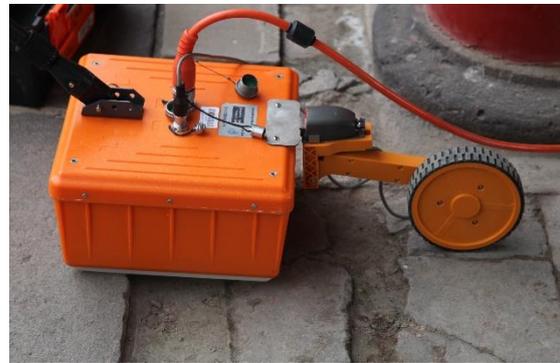
Figure 5 Ground penetrating radar

GPR is a method of using radio waves at the frequency of 106-109Hz to determine underground media distribution. It is mainly composed of integrated frames, antenna and related accessories (Figure 5). GPR detects target by emitting high-frequency broadband short-pulse electromagnetic waves to the ground or target body through the transmitting antenna. The waves are then reflected by subsurface stratigraphy or target body, and received by the receiving antenna. The path, field strength and waveform of electromagnetic wave, while propagating in the media, will change with the changes of the dielectric and geometric properties of the media (Figure 6)^[4]. As the difference in the dielectric constant of air and soil is significant, GPR will get intense reflected signals when the target body has obvious gaps or holes. As shown in the figure 7、8, from the south side of the main hall of the east gable, there is a void phenomenon below 200mm-650mm of the foundation at 10m of the wall.

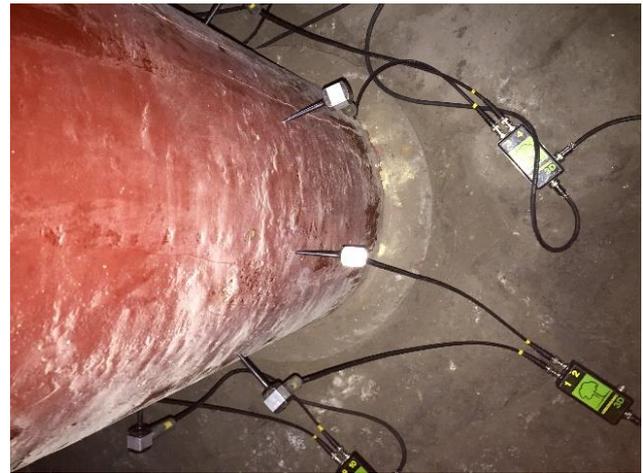
Stress wave technology, detecting wave velocity and vibrational spectrum through sensors, is one of the most common methods of non-destructive testing of wood and wood-based composites^[7]. Depending on the actual diameter of the detected object, we can arrange 6, 8, 10 or even more sensors around the detection section (Figure 9). The shorter the diameter is, the fewer sensors are needed. And the more sensors, the more accurate the test value will be. The height of the detection section was determined by the height, the appearance damage and the surrounding environment of the wooden structure. Researches have shown that stress wave of healthy wood propagates in a certain range of

Figure 9 stress wave probes in operation

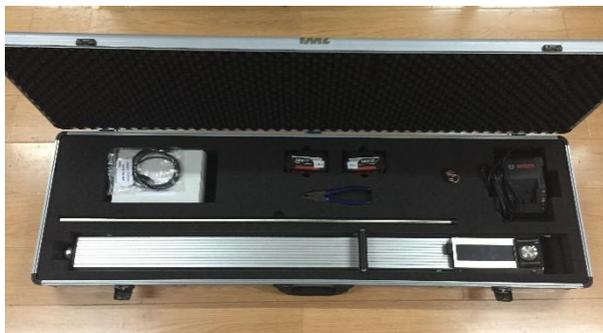
Figure 12 Resistograph

The wood resistograph mainly composed of probe (and its protection device), the microcomputer system and the storage battery (Figure 12). To detect damages, the micro-probe, 1.5mm in diameter, driven by motor, was stabbed into the interior of wood at a uniform rate. The computer records what the resistance pressure is for this process into the memory card, and print the output test photos, which were processed into two-dimensional graphics to indicate internal defects in the pillars section [2](Figure 13). The resistograph maps decayed degrees and wood age through different resistance values, and form curve image. Moreover, with the help of stress wave detection, which could

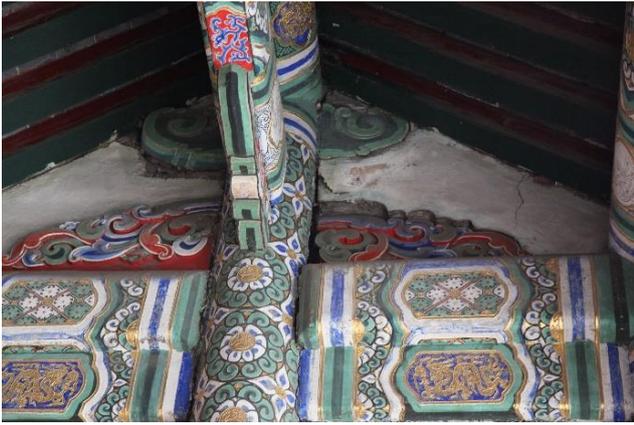
Figure 14 Wooden structure cracks of the temple gate

There are two kinds of cracks: entire crack and partial crack. The cracks of the temple were mainly in walls, beams, pillars, eave-rafters, etc. (Figure 14、 15). For example, there are cracks in the east and west gable of the temple gate, which are about 20mm wide at the top and 10mm wide at the bottom (Figure 16). 80% pillars in the main hall have cracks, such as part of Liang Fang, boarded door, and eave-rafters. There are two main reason for the cracks. One is that the structures have been worn down by the years and fallen into disrepair. Long-time load has weakened the bearing capacity of beams and pillars and leads to cracking. The other reason is that the moisture erosion has caused different swelling or shrinkage inside and outside the wood fibers, which lead to the structure cracking.

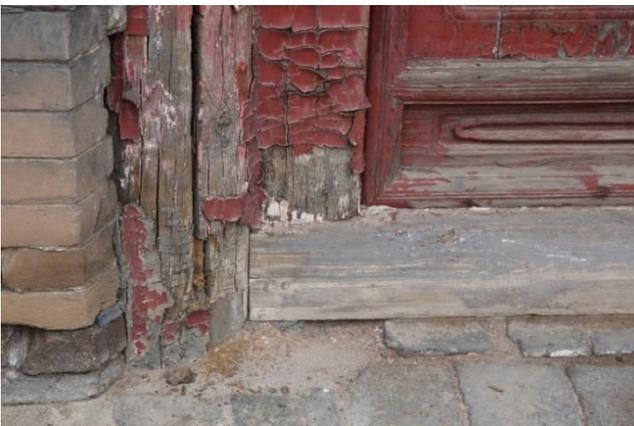
Figure 15 pillar cracks of the temple gate

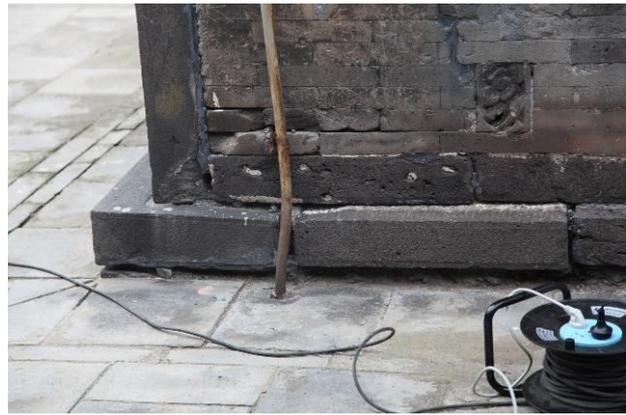
Figure 19 Settlement of the pedestal of the temple gate

Uneven settlement of the foundation would cause the tilt and decline of the walls and wooden structure. In Ancestral Temple in Mukden Palace, the most obvious settlement happened around the temple gate (Figure 19). Through the application of the GPR, we found that the uneven settlement (Figure 20、21) of the pedestal in the northwest corner of the temple gate led to the cracks in the wall and serious decline in the wooden structure (Figure22), threatening the stability and safety of the entire building.
