# PHOTOGRAMMETRY USING VIRTUAL RESTORATION OF WALL-PAINTINGS OF THE ROCK-HEWN CHURCHES IN THE GÖREME VALLEY, CAPPADOCIA AND ITS VALUE FOR THE MUSEUM'S CONTENTS

R. Higuchi<sup>1,\*</sup>, H. Sugawara<sup>2</sup>, M. E. Gülyaz<sup>3</sup>

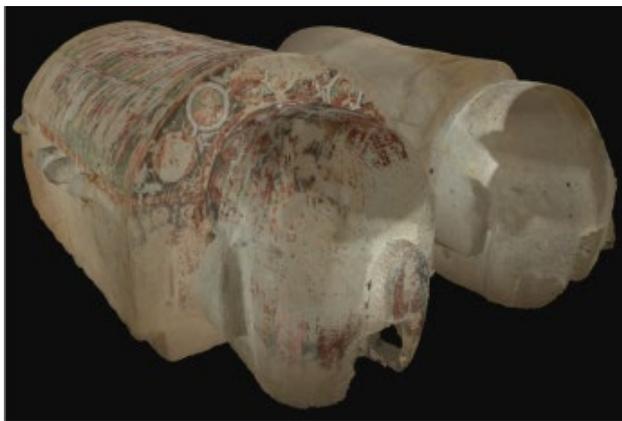
Figure 2. 3D-Modeling of Agios Eustathios Church

The first method of virtual restoration is virtual toning, i.e. to fix colors of the small scars or detachments of paintings. We made the 3D-modeling of the Agios Eustathios church (the first half of 10th century), located outside of the Open-Air Museum, by Agisoft PhotoScan with 120 pieces of photos (Figure 2). Then we acquired four pieces of textures (8000-pixel x 8000-pixel) of 3D-modeling to maintain a high-resolution (Figure 3). As Figure 4 (seen in the red box of figure 3) shows, there are several kinds of damage found on the wall-paintings. Among these, we can assume the colors of the small lost part based on the composition of the icons. Figure 5 is an example to tone the color using 'Eyedropper Tool' of Photoshop. Although this is just fixing the smaller lost parts of the icon, the painting itself becomes clearly distinct and makes the viewers imagine the original condition easily even for non-professionals.

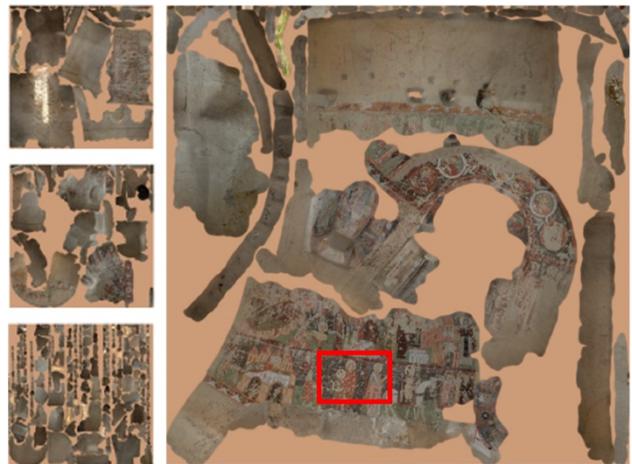
Figure 3. Four textures of wall-paintings of Agios Eustathios

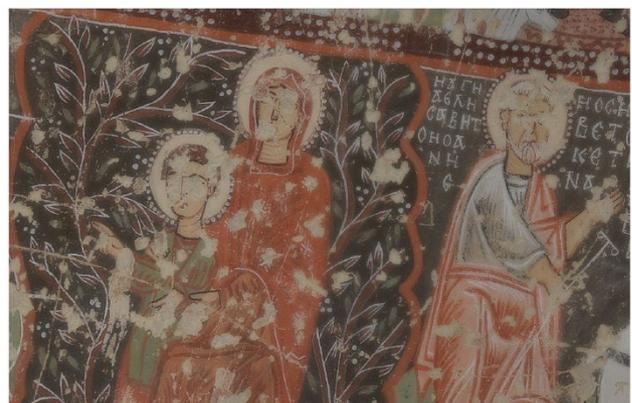
Figure 4. The current condition of the wall-Painting

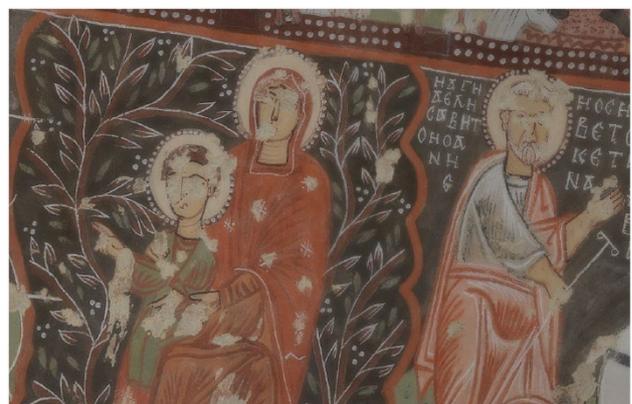
Figure 5. Wall-painting after virtual toning

However, depicting brush strokes or gradations of the colors, or painting habits to the 3D-modeling is very difficult technically as the toning is filling the color using the existing part. Therefore, while it is questionable whether it is realistic as it may require extremely high-performance PC, it needs photos with oblique rays or closeup photos to include such information to the 3D-modeling to depict brush strokes or the painting habits.

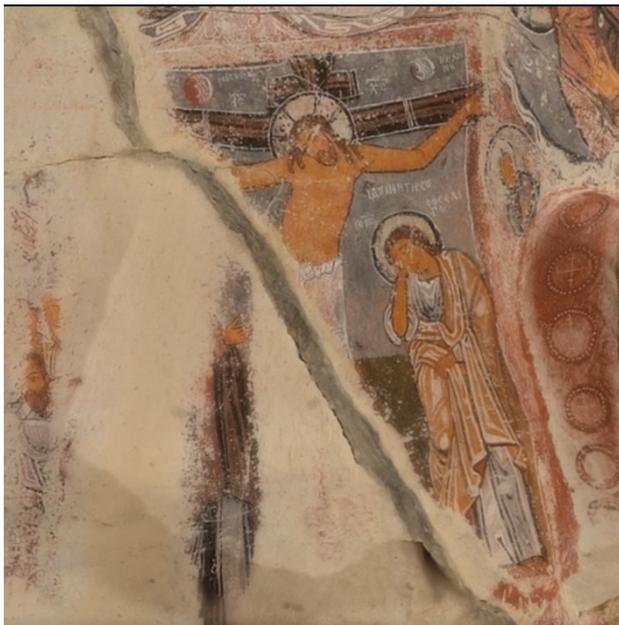
The other method of virtual restoration is virtual reconstruction, which fills the large lost part of the wall-painting. Using the orthophoto made from the 3D-modeling, we sampled the Crucifixion of Merymana Kilisesi (Figure 6). The Crucifixion of here lost the image of St. Mary except for her right hand and the small part of her robe because of a crack formed in the wall which allowed water to penetrate and damage the painting

Figure 6. The Crucifixion of Merymana Kilisesi (current image)

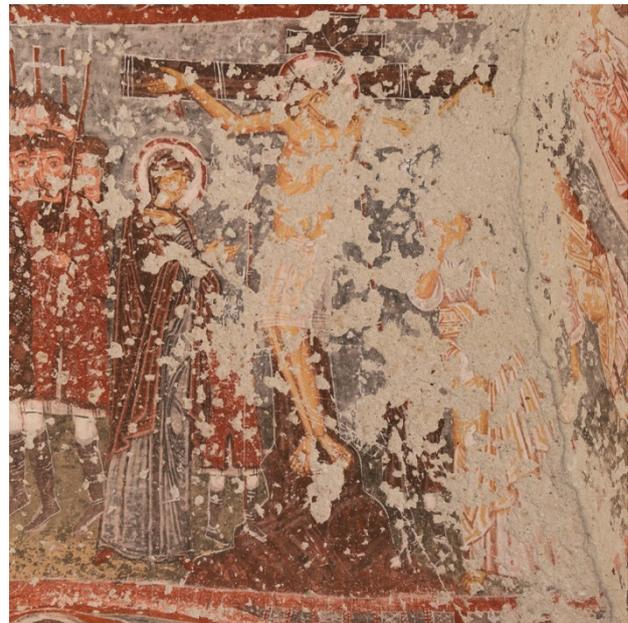
Figure 7. The Crucifixion of Sarnıç Kilisesi (current image)

- 1) Choose the image of transfer: there are two churches called Sarnıç Kilisesi and Karabulut Kilisesi in Zemi Valley within walking distance from the Open-Air Museum. Thierry (1996) pointed out the same painter (or workshop) painted these three churches based on the styles. While Karabulut Kilisesi lost the Crucifixion, Sarnıç Kilisesi's depiction remains, whose St. Mary (left) keeps almost the original form through the icon of St. John the Theologian (right) is heavily damaged.
- 2) Make orthophoto of the Crucifixion of Sarnıç Kilisesi (Figure 7) and Conduct the virtual toning to the icon of St. Mary in Sarnıç Kilisesi (Figure 8).

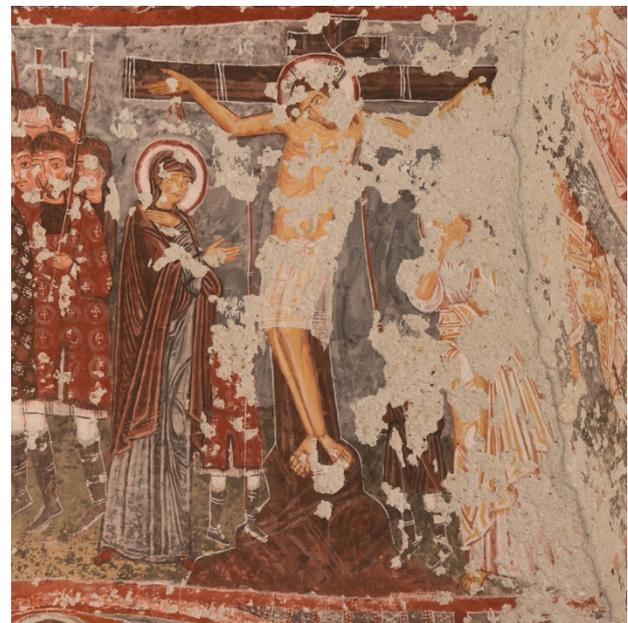
Figure 8. The Crucifixion of Sarnıç Kilisesi (after Virtual Toning)

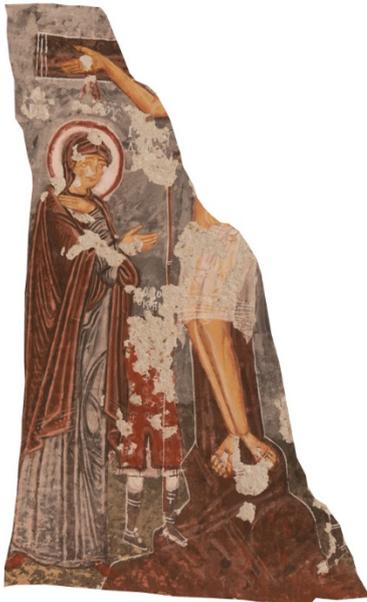
Figure 9. The Virtual toning applied icon of St. Mary in Sarnıç Kilisesi in order to transfer into the Crucifixion of Merymana Kilisesi.

- 3) Transfer the part of the icon of St. Mary in Sarnıç Kilisesi (Figure 9) into the Crucifixion in Merymana Kilisesi and Modify the size and color of the icon (Figure 10).

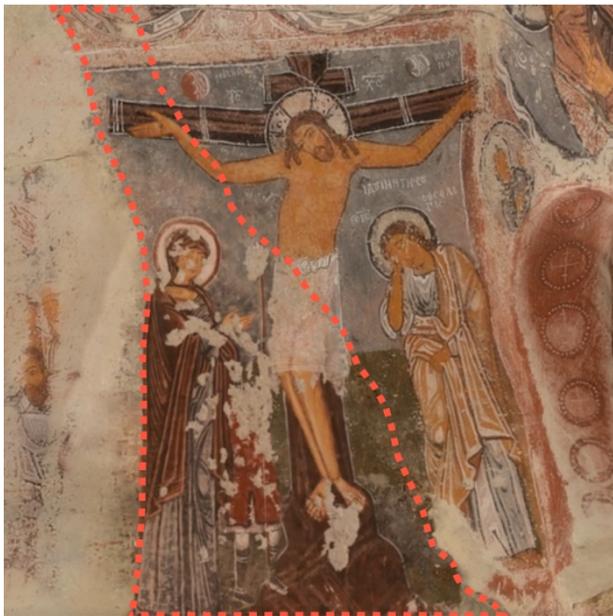
Figure 10. The Crucifixion of Merymana Kilisesi after Virtual Reconstruction (The red dotted line area is the part where virtual reconstruction applied)

Whilst there is a Roman warrior with a spear in front of St. Mary in the reconstructed image, there may be no warrior icon in the original of Merymana Kilisesi as there is no warrior in front of St. John the Theologian of the Crucifixion of Merymana Kilisesi. Therefore, the warrior must be erased.

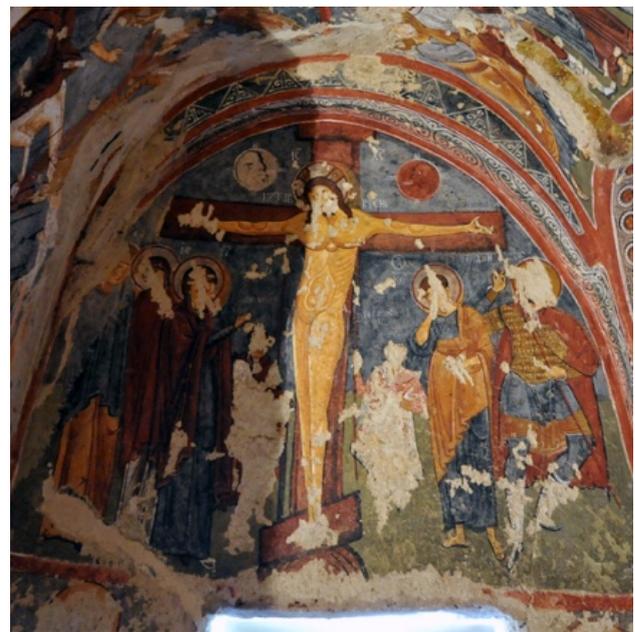
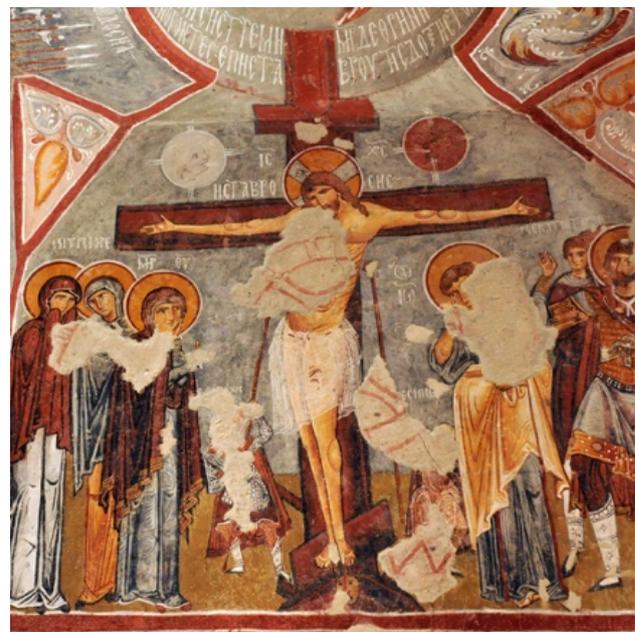
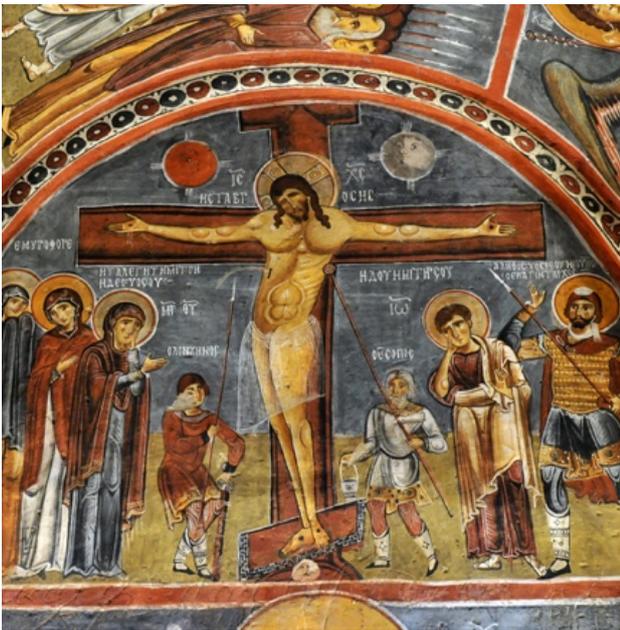
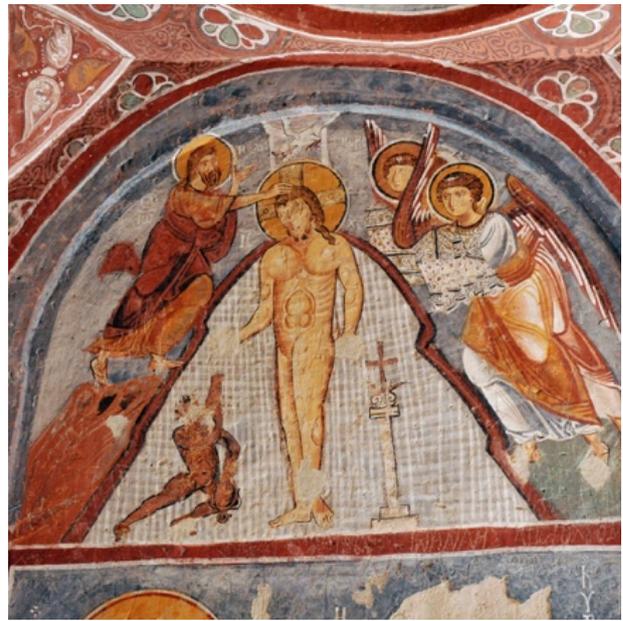
Figure 11. The Comparison of the current images of Crucifixion of 'Column Churches'

addition to having a similar cross-in-square plan (Epstein 1980–81). For instance, the iconography of Crucifixions of the three are close resemblances (Figure 11); i.e. the physiognomy, the drapery and the depictions of muscles in the berry or arms are similar. The iconography of Baptism is as well; the physiognomy, the drapery, the composition, St. John the Baptist is left side of the River and angels are right side of the River, and the depictions of Jordan River, applying white grid to depict streamflow while the Baptism of Çarklı Kilise lost a major part of it due to a physical damage (Figure 12-a) and the Baptism of the other two churches (Figure 12-b–c) are preserved almost perfect composition. Therefore, we believe to be able to reconstruct the Baptism of Çarklı Kilise virtually by transferring the images from the Baptism of the other two churches and subsequently editing the final result.

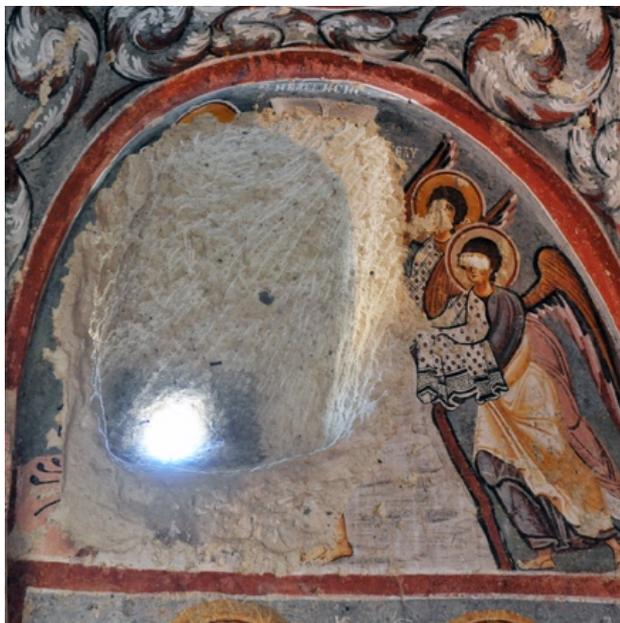
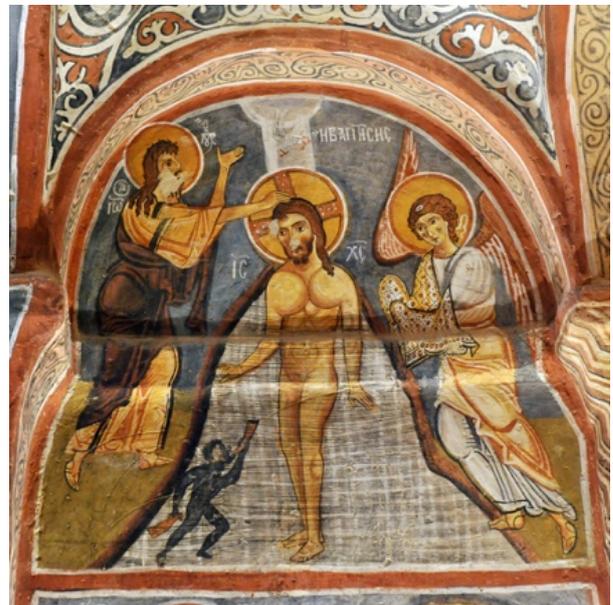
Figure 12. The Comparison of the current images of the Baptism of 'Column Churches'
