## THREE DOCUMENTATION SCENARIOS FOR THE LONG-TERM PRESERVATION OF DECORATED SURFACES IN THE CHURCH OF KUÑOTAMBO, PERU

**KEY WORDS:** Decorated Surfaces, Mural Painting Conservation, Cultural Heritage Documentation, Heritage Record, Long-term Preservation, Monitoring, Documentation Scenarios

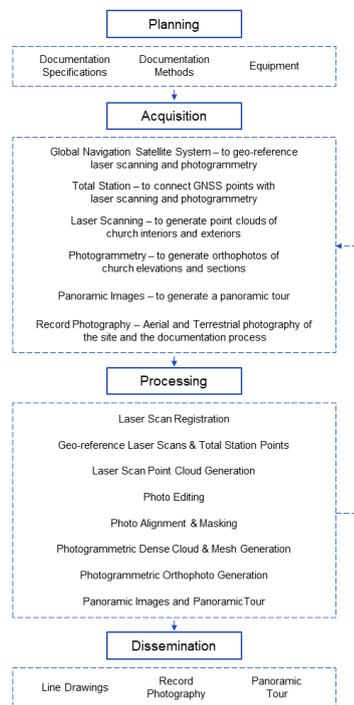
Figure 4. Documentation project workflow (planning, acquisition, processing, dissemination). Diagram by CIMS © GCI 2019.

After the conservation and seismic retrofitting works were completed, there was a need to document the site again to provide a baseline for the monitoring activities and the long-term care of the church (Figure 4). A recording campaign was carried out at the end of 2019 and included the urban context of the church (Figure 5), the building (Figure 6) and the mural paintings (Figure 7). Additionally, CIMS collaborated with the wall painting conservators of the SRP team and the Ministry of Culture of Peru in Cusco to prepare guidelines for the acquisition and processing of data that would allow them to compare subsequent datasets generated in future monitoring activities.

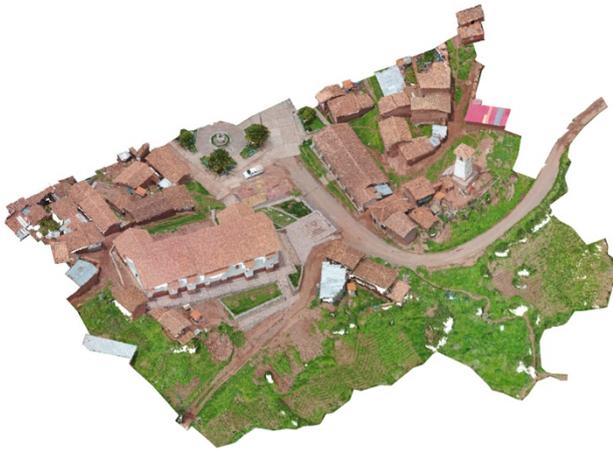
**Figure 5.** Aerial photogrammetry of Kuñotambo. Image by CIMS © GCI 2019.

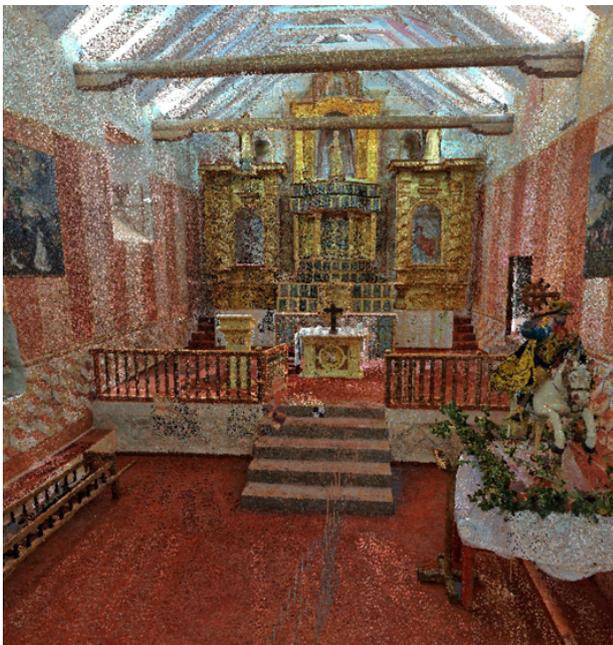
**Figure 6.** Consolidated interior Point Cloud of the church. Image by CIMS © GCI 2019.

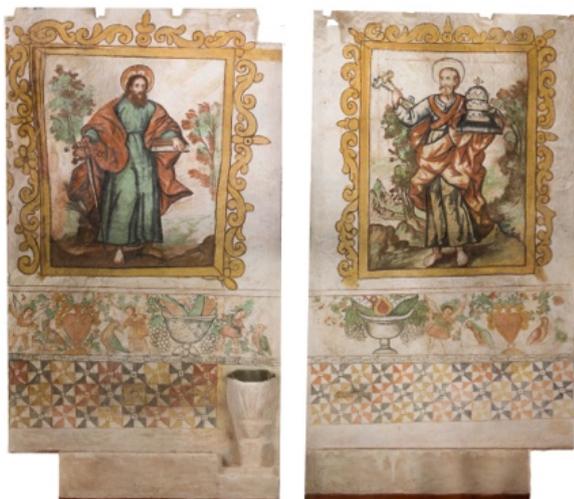
**Figure 7.** Detailed terrestrial photogrammetry of the mural paintings in the area below the choir loft. Image by CIMS © GCI 2019.

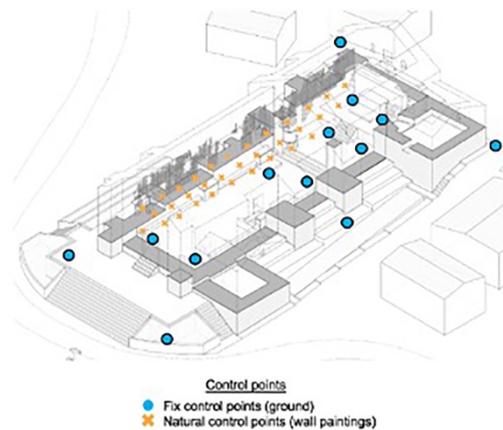
**Figure 8.** Fixed and natural control points (geodetic network). Diagram by CIMS © GCI 2019.

During the 2019 campaign, the CIMS team set up a geodetic network measured using a Reflectorless Electronic Distance Measurement (REDM) Total Station Leica Geosystems model Viva TS11 in the inside and immediate surroundings of the outside of the church. This made it possible to combine all the different datasets generated (3D Laser Scanning, aerial and terrestrial photogrammetry) in the same survey network and allow future campaigns to use it as reference. The geodetic network was comprised of fixed control points on the ground and natural control points on the mural paintings (Figure 8). These two types of control points generated a robust and permanent survey network on the ground from which to measure the mural paintings and use them as a reference for future campaigns.

The fixed control points on the ground used metal screws drilled to a solid surface and fixed with epoxy to ensure their position over time. The placement of each of the points was discussed and agreed upon between the SRP team and Ministry of Culture staff, inserting all the fixed points in stable and non-historic areas. For the post-intervention documentation of the mural paintings on the interior of the church, and in order to not to damage their historic fabric, natural and easily recognizable control points such as frame corners or bird beaks were surveyed. For each of the fixed and natural control points, a witness sheet (Figure 9 and 10) was provided that detailed the Ground Control Point (GCP) number, the coordinates, a description of the location, a contextual photograph and a detailed photograph, and general information on the project (project, date, survey point, and source).

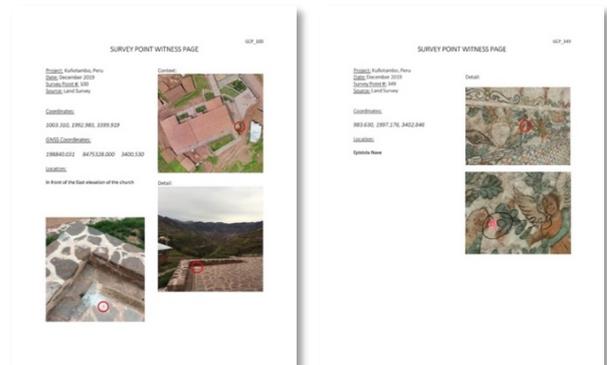
**Figure 9-10.** Witness Sheets (fixed GCP 100/natural GCP 349). Images by CIMS © GCI 2019.

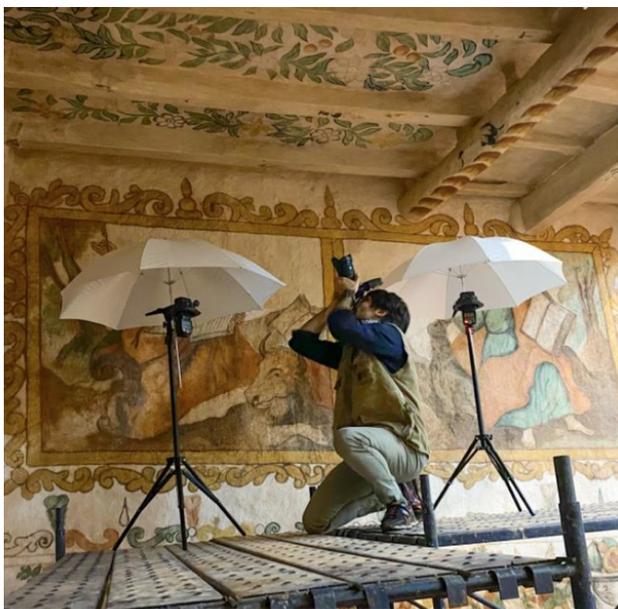
**Figure 11.** Recording of decorated surfaces with scaffolding, flashes, and light-diffusers below the choir loft.  
 Photograph by CIMS © GCI 2019.

After discussion with the SRP team, CIMS determined that close range photogrammetry (Figure 11) was appropriate to capture the desired level of detail for the mural paintings. One of the major challenges of the photogrammetric project was obtaining an adequate and even distribution of light during the photographic acquisition due to the height of the interior church walls (7 m height).

1. Main spaces would be captured using the available artificial and natural lighting; and,
2. Bottom and specific areas would be captured using a set of two flashes per camera mounted on tripods to control lighting and get homogeneous exposure.

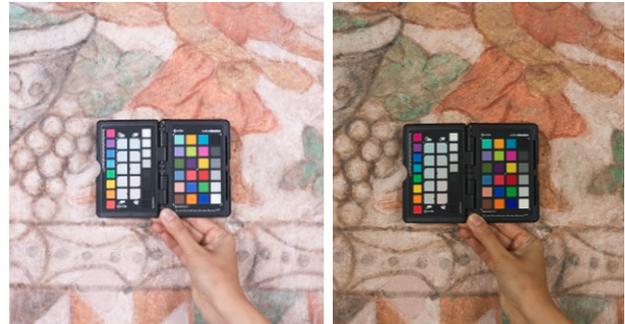
**Figure 12.** Correcting Color with ColorChecker in the north wall of the nave. Images by CIMS © GCI 2019.

It was important to ensure that the photogrammetric models correctly represented the mural paintings. The use of an X-Rite ColorChecker Passport allowed for consistent, repeatable capture of the decorated surfaces. The ColorChecker was used to create a profile for the camera in the specific lighting conditions, correct the exposure, and correct the white balance (Figure 12).

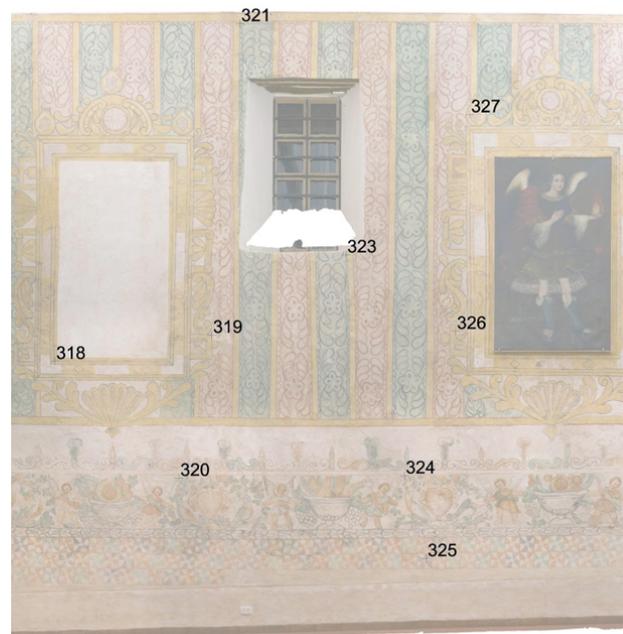
**Figure 13.** Upper: Samples of natural control points of the geodetic network on one section of the mural paintings and marked on the ortho-corrected image. Lower: Three reference images of the natural point locations GCP 318, 325, and 327.  
 Images by CIMS © GCI 2019.

Finally, the photogrammetric model was generated using Agisoft Metashape and geo-referenced to the survey network using the fixed and natural control points measured previously with the REDM Total Station (Figure 13). In parallel with the photogrammetric process, the exterior and interior of the church were documented with a terrestrial 3D Laser Scanner Faro Focus 3D that generated a Point Cloud with a density of at least 6mm between each point. This dataset was the primary source to elaborate the architectural drawings of the building, and was also used to verify the alignment of the photogrammetric project.

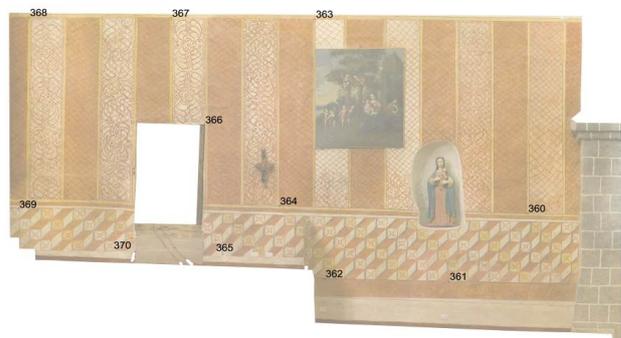
Figure 15. Ortho-corrected image used as a reference in Scenario 1. Image by CIMS © GCI 2019.

- Carry out an assessment of the mural paintings through visual inspection, identifying and marking conditions on the printed line drawings with ortho-photography of the mural paintings generated in the heritage documentation report in 2019 (Figure 14); and,
- Based on the documentation collected on-site, update the existing raster images (.jpeg) and/or vector (.dwg) with changes identified with comments or drawings.

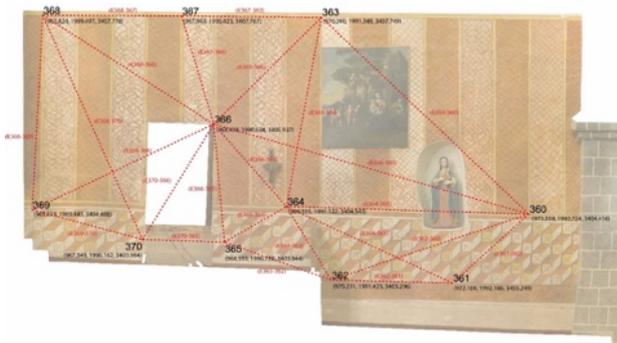
**Figure 17.** Ortho-corrected image used as a reference to triangulate measurements in Scenario 2. Image by CIMS © GCI 2019.

- Precision and speed of metric data acquisition by manual procedures;
- Difficult to precisely determine the surface movement;
- Direct measurements might be challenging without scaffolding, and the use of measuring tape might produce damage to the surface; and,
- Need to triangulate all the existing fixed and natural points to see if any deviations happen over time (Figure 17).

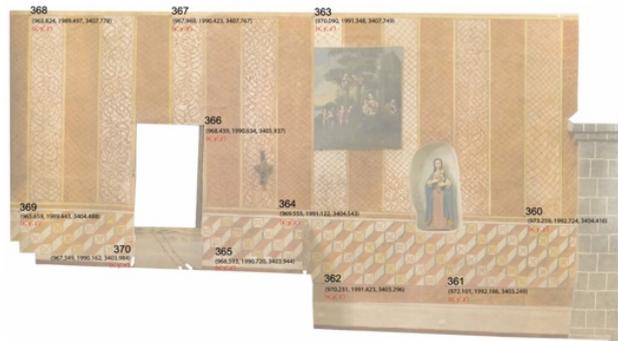
**Figure 19.** Ortho-corrected image used as a reference to compare x, y, and z coordinates of GCPs in Scenario 2. Image by CIMS © GCI 2019.

If the measurements are taken digitally with a REDM Total Station (Figure 18), this requires a more substantial investment of time and equipment and the involvement of a geomatics expert, along with wall painting conservators. The advantage is that this system generates precise metric positions (Figure 19) that will be easy to compare with the previous records. However, the following requirements must be taken into account:
